District Department of Transportation

15TH STREET NW
TRAFFIC CALMING STUDY
DRAFT REPORT

DCI
DANIEL CONSULTANTS, INC.

June 23, 2006

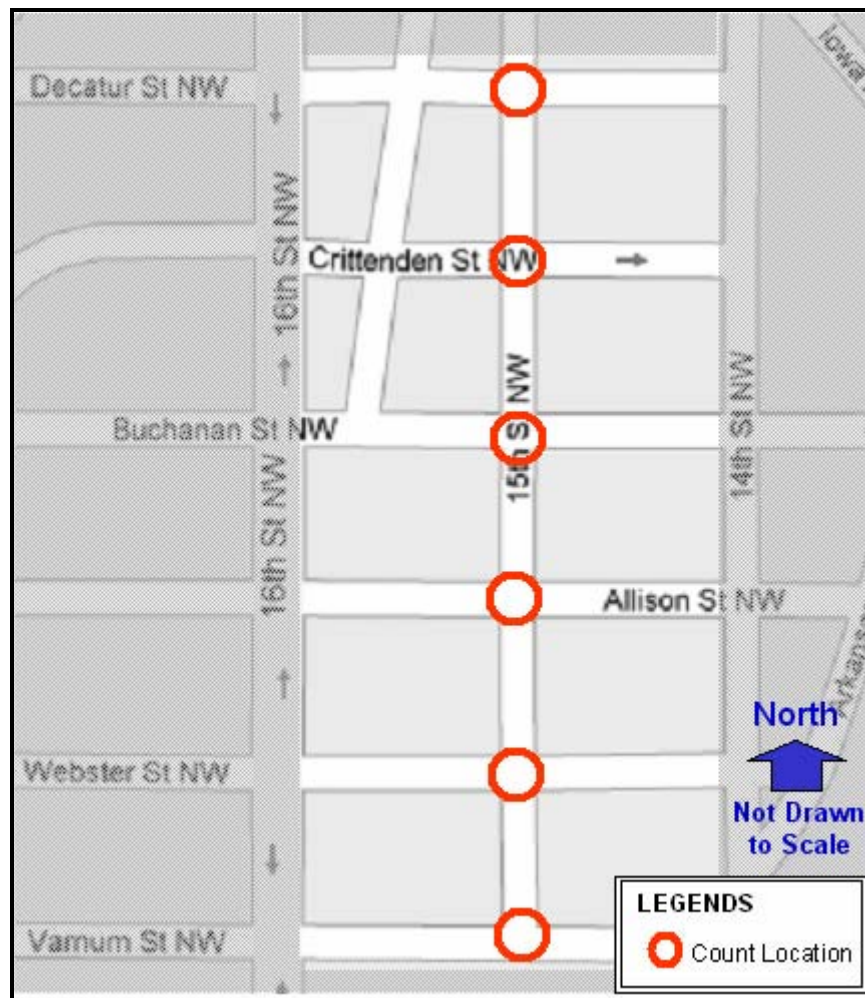
Figure 4. Locations of Manual Intersection Turning Movement Counts

Turning movement data were collected at 6 intersections in 15 minutes intervals for 13 hours during the typical weekdays. The turning movement data included basic classification (i.e., cars, bus, trucks, bicycles, and pedestrians). Figure 4 shows the locations of the counts.

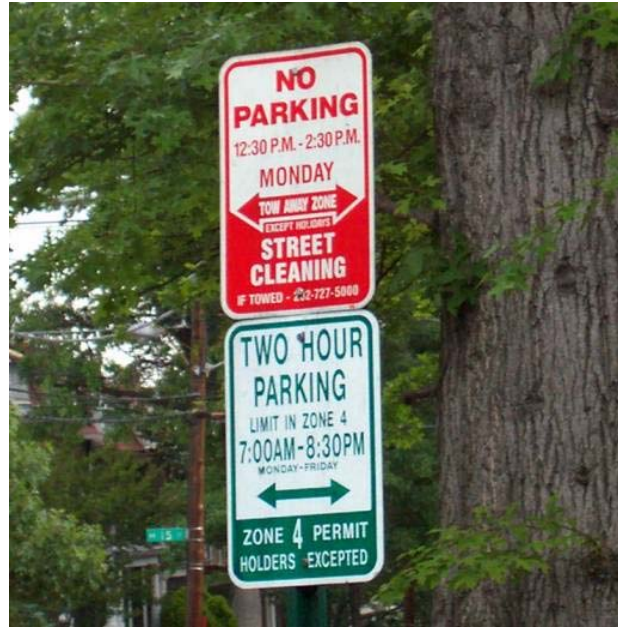
Figure 11. Typical Parking Signs in the Study Area

There is on-street parking throughout the study area. Residential Parking Permit Parking (RPP) regulates the street parking during the daytime hours, from 7:00 AM to 8:30 PM on Monday through Friday, as shown in Figure 11. On Mondays or Tuesdays, parking is restricted on one side of the street for several hours for street cleaning. During a survey of the street inventory, there were no cars found to be illegally parked.

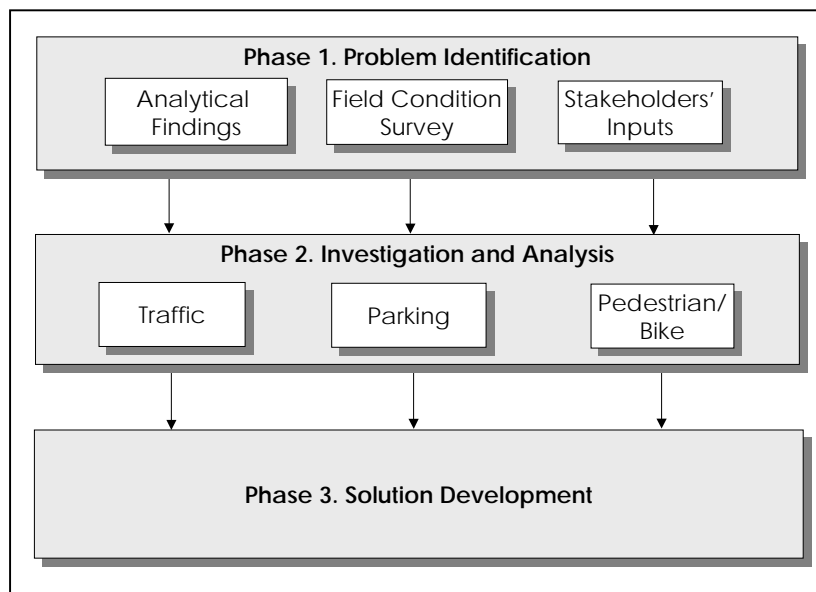
Figure 13. Study Methodology

Figure 13 presents an overview of the study approach. The approach consists of three phases: problem identification, investigation and analysis, and solution development.

As shown in Figure 13, the problem identification has its roots in three (3) primary sources:
