# Final Report

## Summary of Evaluation and Recommendations

# District Department of Transportation Bicycle Facility Evaluation

Prepared By:  
Kittelson & Associates, Inc.  
Jamie Parks, AIC  
Paul Ryus, P.E.  
Alison Tarka

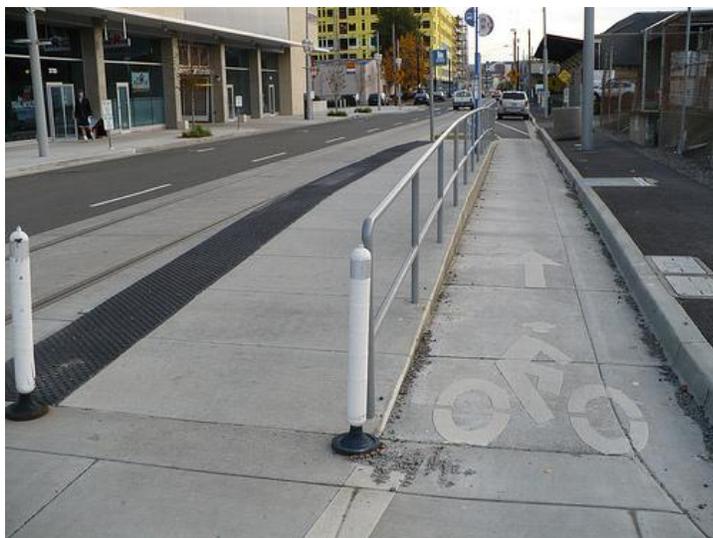
Photo 1 Example Transit Stop Designed to Accommodate Bikes (Portland, Oregon)

Due to the rarity of separated bicycle facilities in the United States, there is no generally accepted design solution to this problem. However, the situation is akin to that of bicycle facilities along streetcar tracks (see Photo 1) where the streetcar stop uses a curb extension and the bicycle facility travels behind the transit stop adjacent to the sidewalk. This treatment is likely to add considerable expense to the construction of bicycle tracks along transit routes, but may be necessary to maintain ADA compliance for transit service.
