**Final Report on  
District Wide  
Highway Safety Improvement Program (HSIP)  
Intersection Skid Resistance Testing**

**District Department of Transportation  
Infrastructure Project Management Administration  
Safety, Standards, and Quality Control Division**

**September 11, 2009**

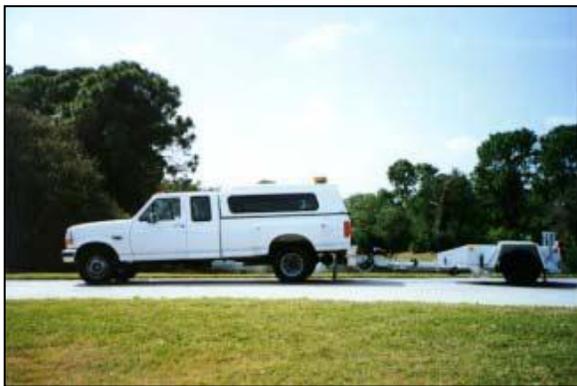
Figure 1 MDR 4040

The Skid Resistance Testing was performed using an International Cybernetics Corporation (ICC) MDR 4040 Pavement Friction Tester. This equipment consists of a Ford E350, dual wheel diesel pick-up truck and a trailer mounted friction tester. The on-board computer controls the friction tester and automatically calculates and records average speed, average skid number (SN) and mileage location of each test. The system also records the GPS location of the start of each test. Figure 1 is an overall view of the test equipment. Figure 2 is a close-up showing the smooth test tire mounted on the trailer and the water nozzle which is used to flood the pavement in front of the tire during testing.

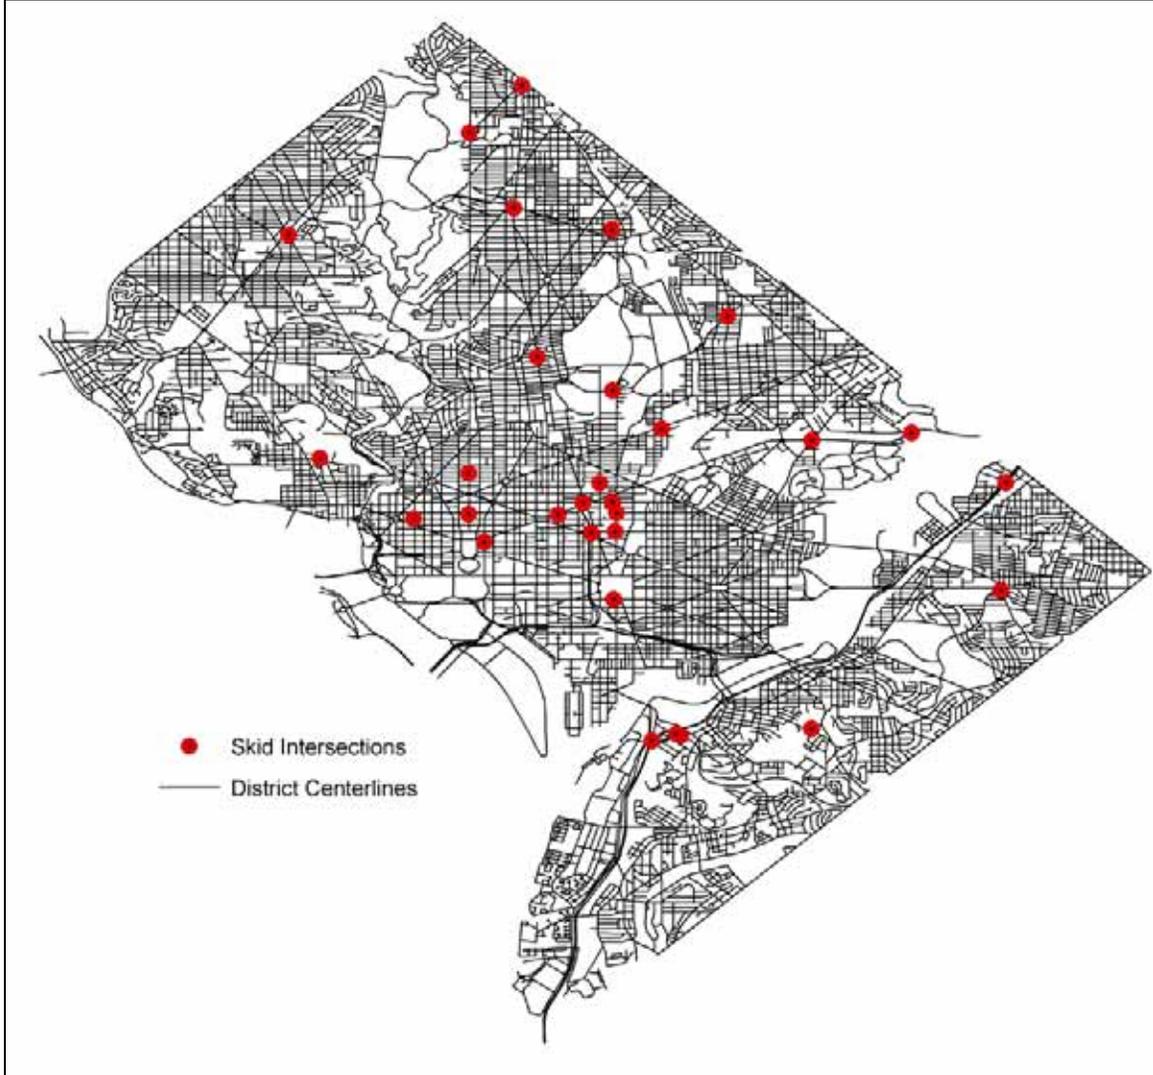
Figure 4 Map of Test Locations

The final list of test locations was obtained from DDOT on July 13<sup>th</sup>, 2009. This list was modified following the first day of field testing to remove the intersection of 3<sup>rd</sup> St. and Interstate 395, NW. This intersection was replaced with Connecticut Ave. and Nebraska Ave, NW. The final list of test locations is shown in Table 1. Figure 4 shows the distribution of the test locations across the District.

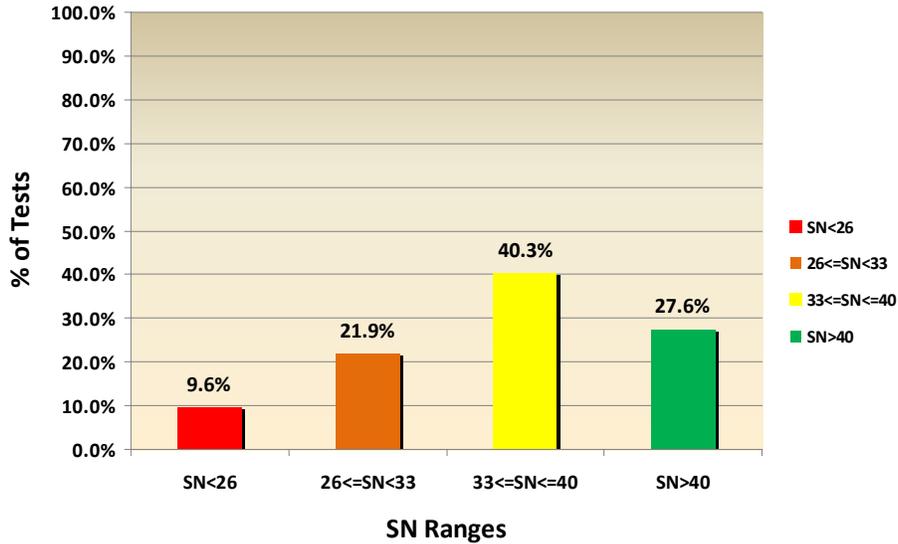
Figure 7 Percent of SN values in each Range across all Test Locations

Overall, the results of the skid resistance testing across all test locations were good with 67.9% of the tests resulting in SN>=33. This breaks down further to 27.6% with SN>40 and 40.3% with SN between 33 and 40. Only 9.6% of the tests resulted in SN values less than 26. These results are tabulated in Table 3 and shown graphically in Figure 7.

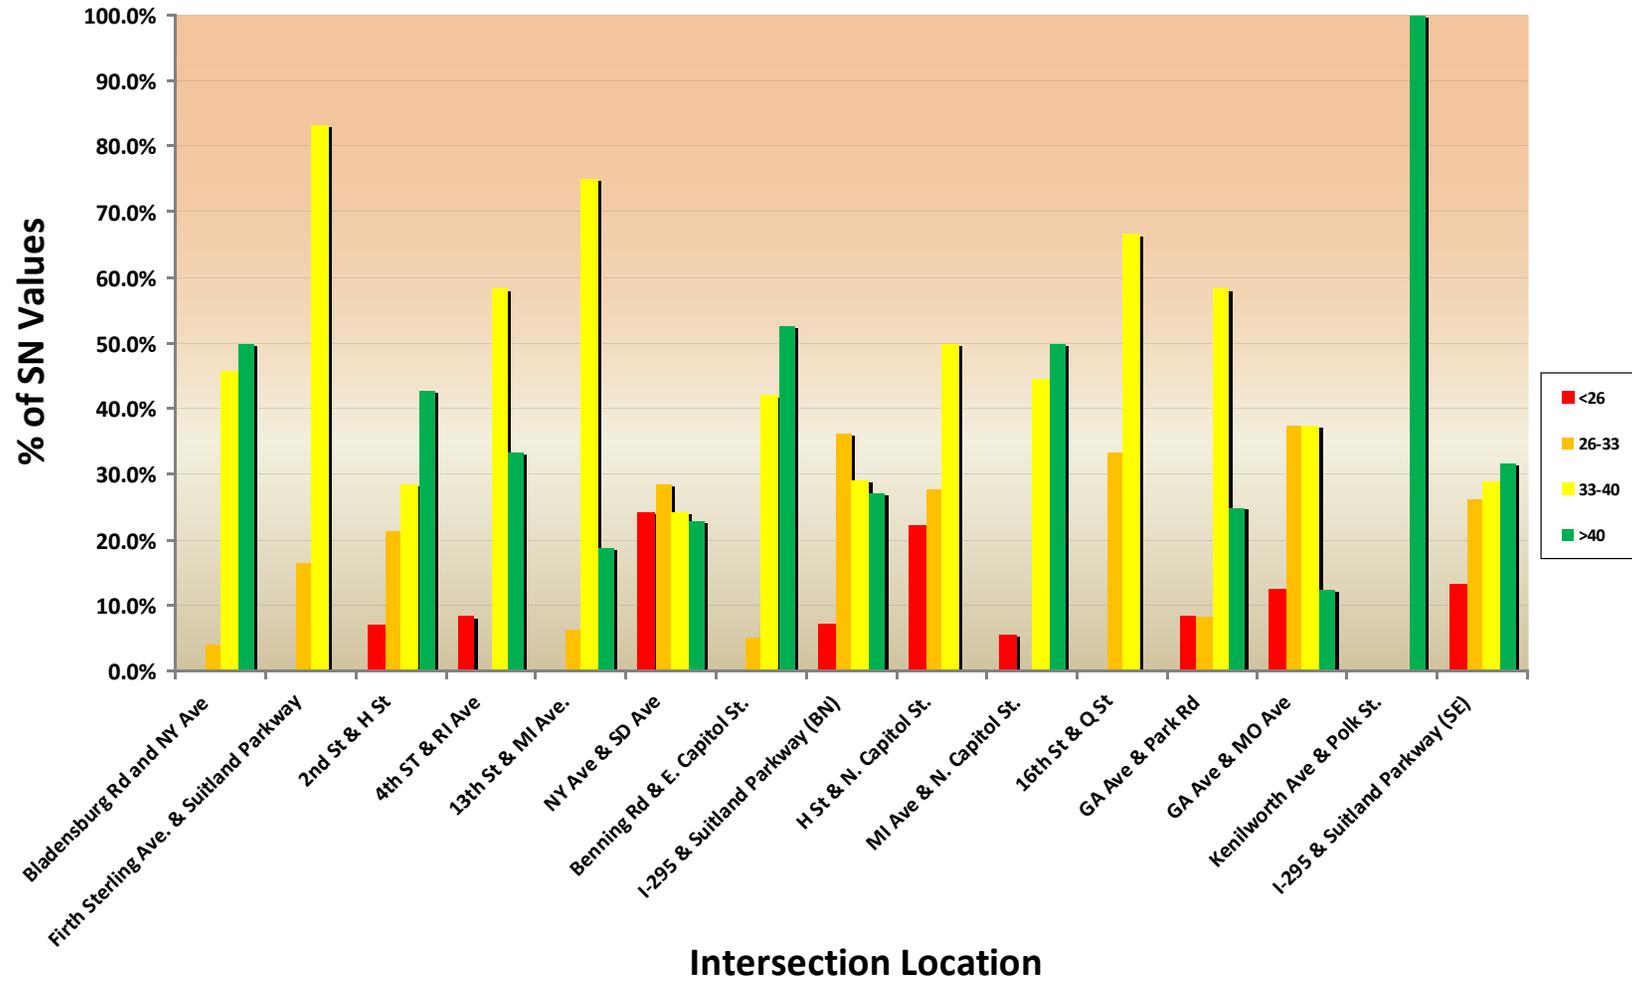
Figure 8A Summary of Distribution of Test Results by SN Range and Test Location, part 1

The distribution of the percent of skid tests in each SN range for each test location is shown in Figures 8A and 8B. Fifteen test locations had at least one test point with SN<26. These locations are listed in Table 4.

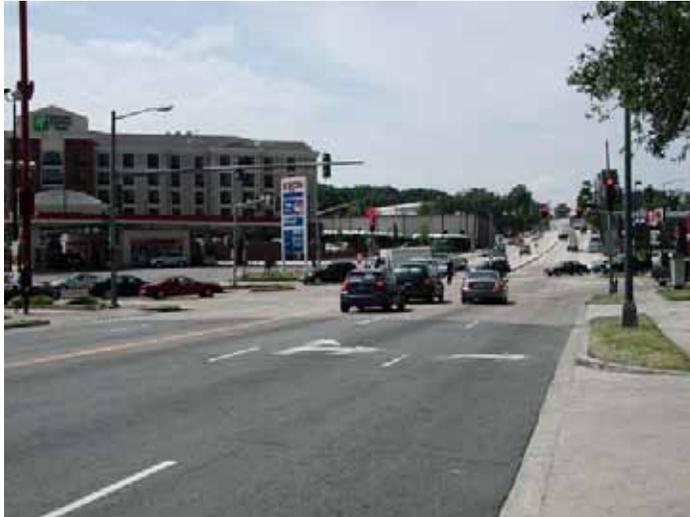
Skid resistance testing was performed on the intersection of Bladensburg Road and New York Avenue the night of July 24, 2009. This is a major intersection of two multi-lane roadways. Figures B1 & B2 are photographs that show the intersection from two angles. Table B1 shows the number of test results that occurred in each of the designated SN ranges. Figure B3 shows the percentage distribution of test results by SN range at this location. None of the test results had an SN<26 and 95.8% of the tests had an SN>=33. Figure B4 is an aerial image of the intersection showing a color coded dot which represents the start point of each skid test.

Figure B1. Taken on Bladensburg Road facing east, this photo shows the intersection with New York Ave.

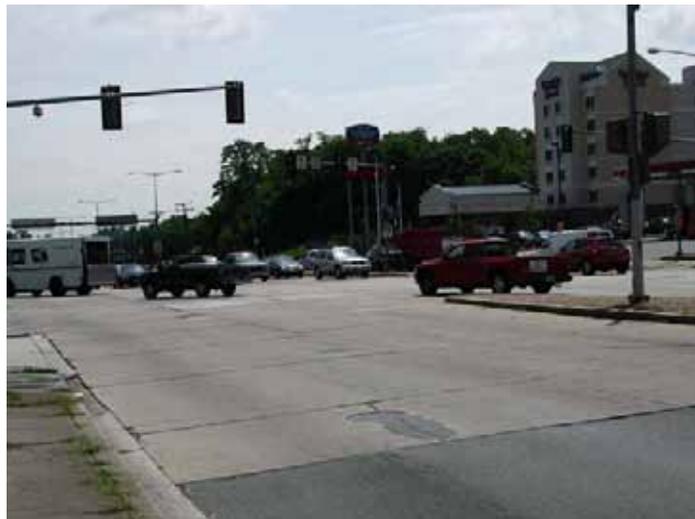
Figure B2. This photo was taken on New York Ave. generally facing north and shows the intersection with Bladensburg Road.

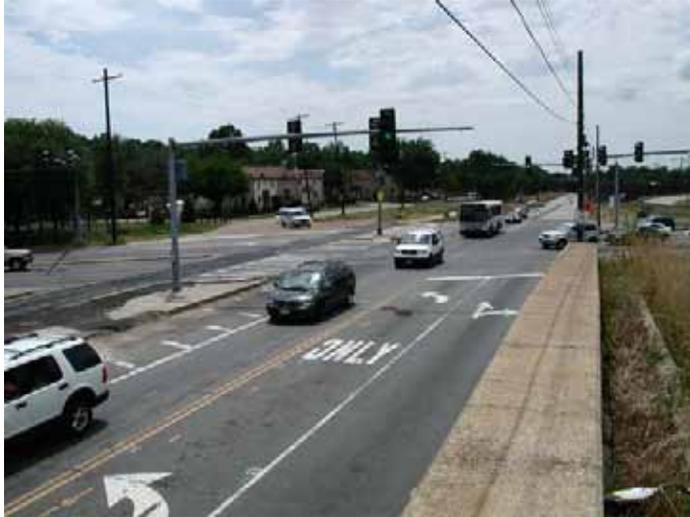
Skid resistance testing was performed on the intersection of Firth Sterling Ave and Suitland Parkway the night of July 25, 2009. Table B2 shows the number of test results that occurred in each of the designated SN ranges. Figure B7 shows the percentage distribution of test results by SN range at this location. None of the test results had an SN<26 and 83.3% of the tests had an SN>=33. Figure B8 is an aerial image of the intersection showing a color coded dot which represents the start point of each skid test.

Figure B5. Taken along Firth Sterling Ave facing generally west, this photo shows the intersection with the Suitland Parkway. It also shows the railroad crossing adjacent to the intersection.

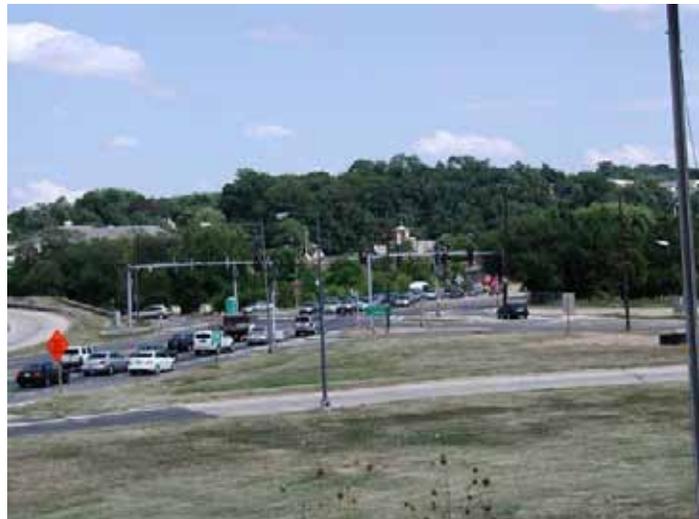
Figure B6. Taken from the shoulder of northbound I-295 this photo provides an overview of the intersection of Suitland Parkway and Firth Sterling Ave.

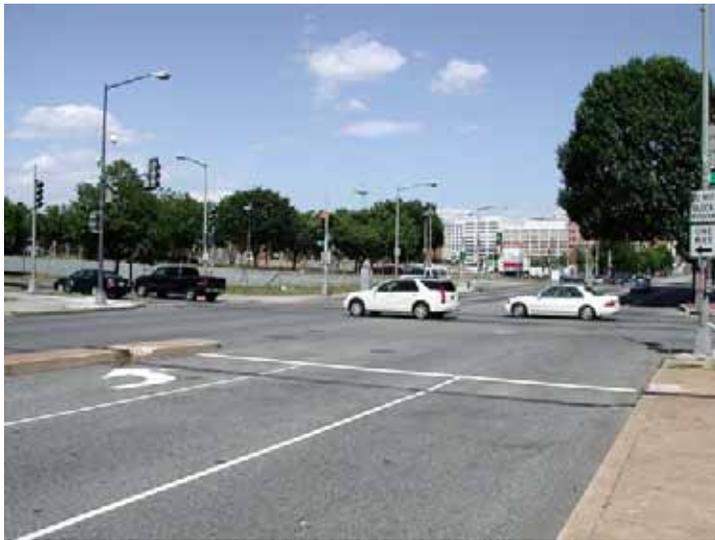
Skid resistance testing was performed on the intersection of 2<sup>nd</sup> Street & H Street the night of July 26, 2009. 2<sup>nd</sup> Street is a one-way street northbound and H Street is a multi-lane roadway. Figures B9 & B10 are photographs that show the intersection from two angles. Table B3 shows the number of test results that occurred in each of the designated SN ranges. Figure B11 shows the percentage distribution of test results by SN range at this location. This location had one test with an SN<26, which was located on 2<sup>nd</sup> Street. Overall, 71.5% of the tests had an SN>=33. Figure B12 is an aerial image of the intersection showing a color coded dot which represents the start point of each skid test.

Figure B9 Taken on H Street facing east, this photo shows the intersection with 2<sup>nd</sup> Street and a “One Way” sign for 2<sup>nd</sup> Street.

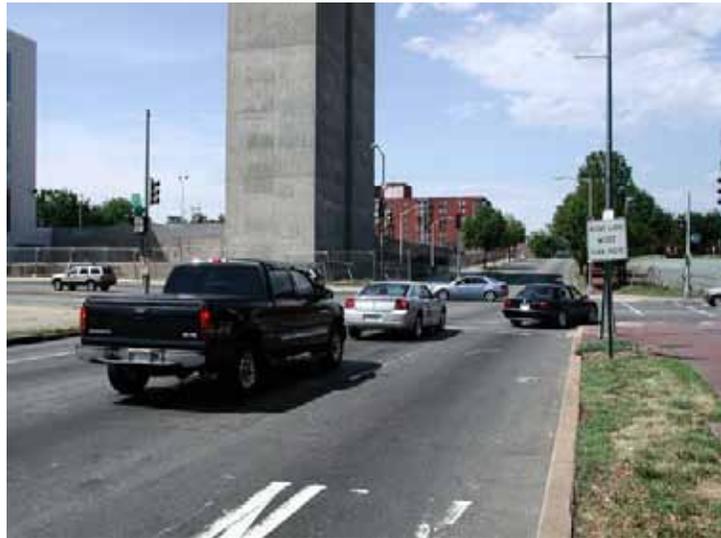
Figure B10 This photo was taken along 2<sup>nd</sup> Street facing north and shows the intersection with H Street.

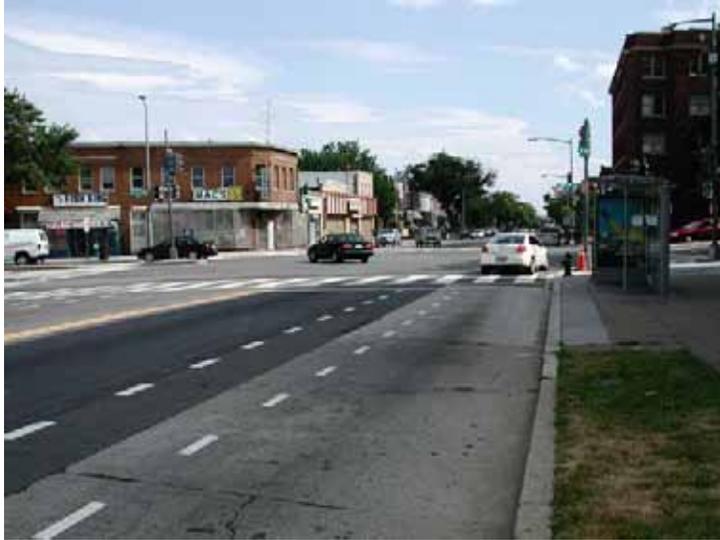
Skid resistance testing was performed on the intersection of 4<sup>th</sup> Street & Rhode Island Ave the night of July 22, 2009. Figures B13 & B14 are photographs that show the intersection from two angles. Table B4 shows the number of test results that occurred in each of the designated SN ranges. Figure B15 shows the percentage distribution of test results by SN range at this location. This location had one test with an SN<26, which was located on southbound 4<sup>th</sup> Street. Overall, 91.6% of the tests had an SN>=33. Figure B16 is an aerial image of the intersection showing a color coded dot which represents the start point of each skid test.

Figure B13. This photo shows the intersection of 4<sup>th</sup> & Rhode Island Ave, as seen from 4<sup>th</sup> Street facing south.

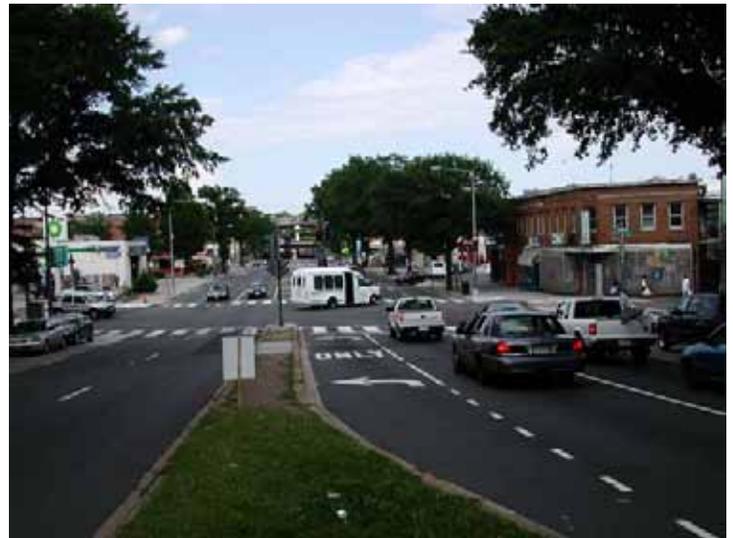
Figure B14. This photo shows the intersection of 4<sup>th</sup> and Rhode Island Ave, as seen from the Rhode Island Ave median facing west.

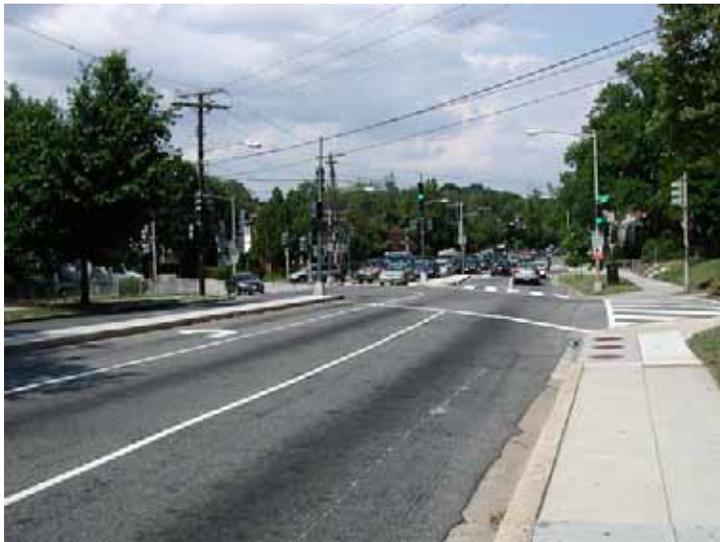
Skid resistance testing was performed on the intersection of 13<sup>th</sup> Street & Michigan Ave the night of July 22, 2009. Figures B17 & B18 are photographs that show the intersection from two angles. Taylor Street also intersects at this location. It was tested along with 13<sup>th</sup> St and Michigan Ave. Table B5 shows the number of test results that occurred in each of the designated SN ranges. Figure B19 shows the percentage distribution of test results by SN range at this location. None of the test results from this location were less than a 26. Overall, 93.8% of the tests had an SN  $\geq$  33. Figure B20 is an aerial image of the intersection showing a color coded dot which represents the start point of each skid test.

Figure B17. This photo shows the intersection of 13<sup>th</sup> & Michigan Ave, as seen from Michigan Ave facing northeast.

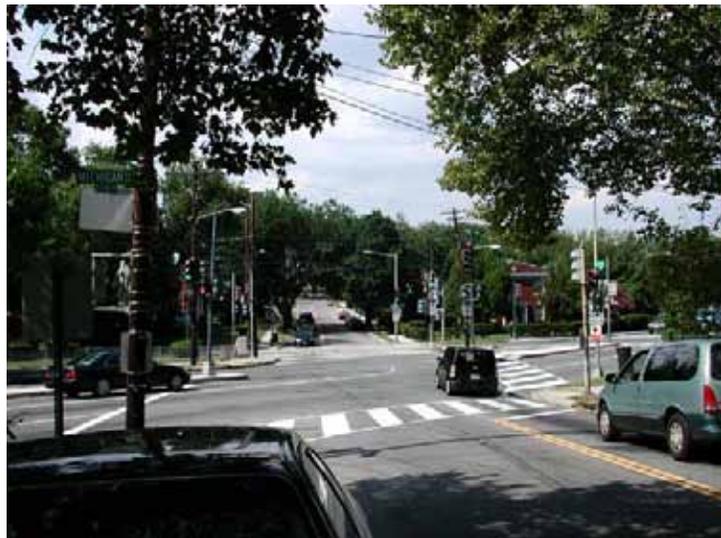
Figure B18. This photo shows the intersection as seen from 13<sup>th</sup> Street facing north.

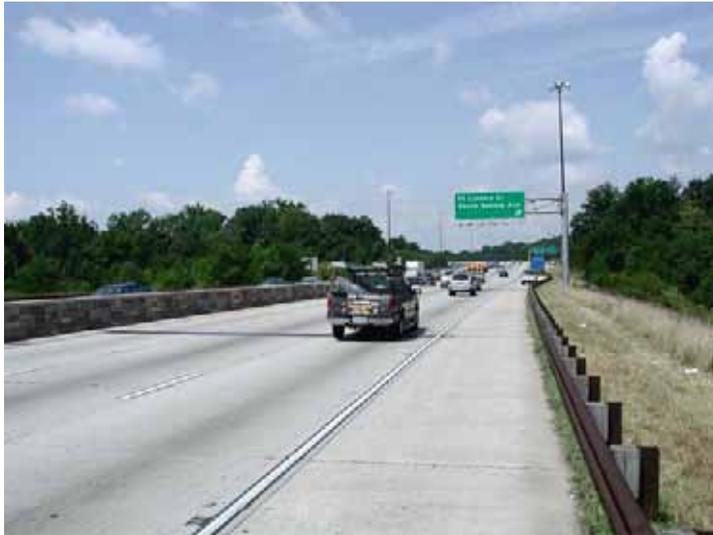
Skid resistance testing was performed on the intersection of New York Ave & South Dakota Ave the night of July 27, 2009. Figures B21 & B22 are photographs that show the intersection from two angles. Table B6 shows the number of test results that occurred in each of the designated SN ranges. Figure B23 shows the percentage distribution of test results by SN range at this location. The test results from this location included 17 tests with SN<26. These tests were primarily on the ramp from New York Ave west to South Dakota Ave, and the ramp from South Dakota Ave to New York Ave east. Overall, 47.2% of the tests had an SN>=33. Figure B24 is an aerial image of the intersection showing a color coded dot which represents the start point of each skid test.

Figure B21. This photo shows the beginning of the off ramp to South Dakota Avenue from New York Ave facing west.

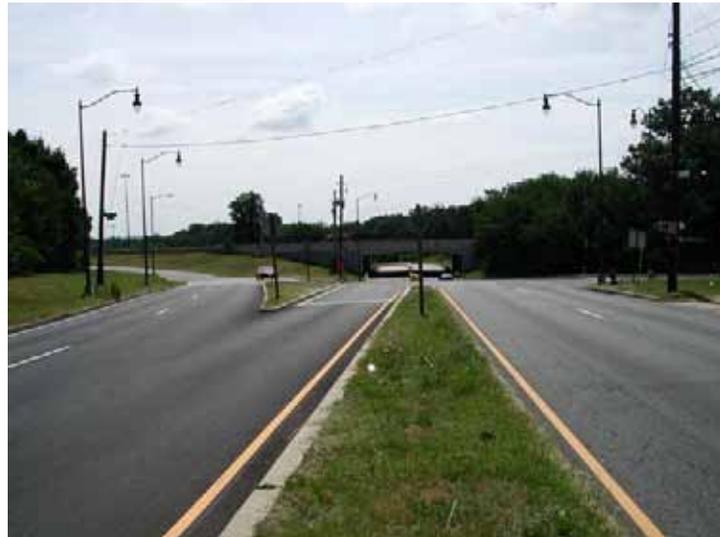
Figure B22. This photo shows the New York Ave & South Dakota Ave Interchange as seen from the median of South Dakota Ave looking east.

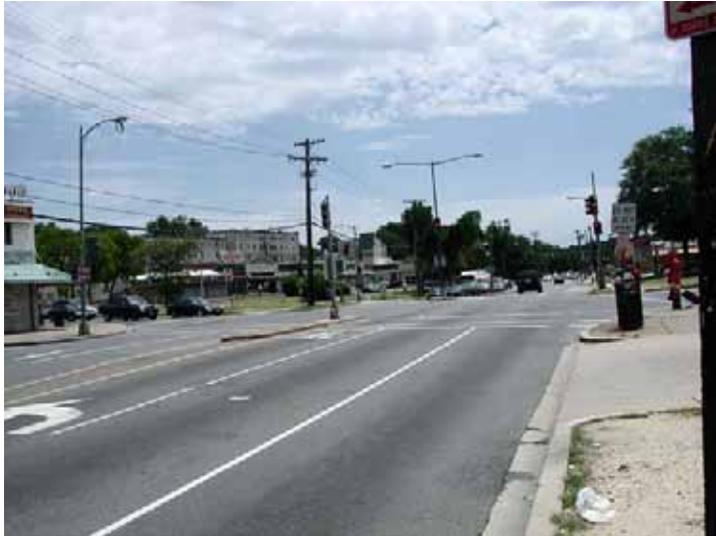
Skid resistance testing was performed on the intersection of Benning Road & East Capitol Street the night of July 25, 2009. Figures B25 & B26 are photographs that show the intersection from two angles. Table B7 shows the number of test results that occurred in each of the designated SN ranges. Figure B27 shows the percentage distribution of test results by SN range at this location. None of the test results from this location had an SN<26. Overall, 94.7% of the tests had an SN>=33. Figure B28 is an aerial image of the intersection showing a color coded dot which represents the start point of each skid test.

Figure B25. This photo shows the intersection from Benning Road facing south.

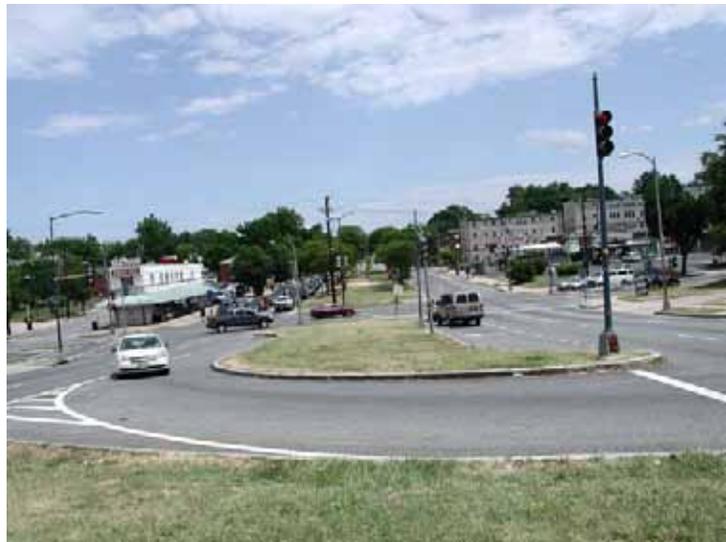
Figure B26. This photo shows the intersection as seen from the median of East Capitol Street facing east.

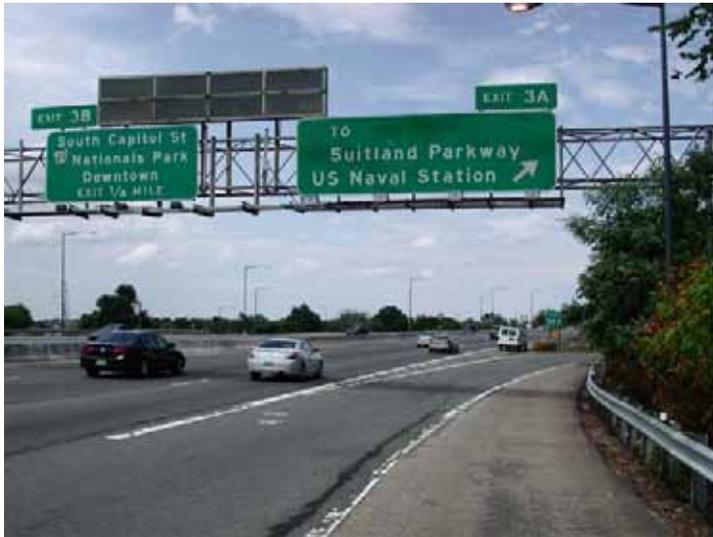
Skid resistance testing was performed on the interchange of Interstate 295 and Suitland Parkway the night of July 25, 2009 and July 26, 2009. This is a major interchange consisting of Interstate 295 and all the ramps exiting I-295 leading to Suitland Parkway. Figures B29 & B30 are photographs that show the intersection from two angles. Table B8 shows the number of test results that occurred in each of the designated SN ranges. Figure B31 shows the percentage distribution of test results by SN range at this location. Four tests (7.3%) resulted in a SN<26 and 56.4% of the tests had an SN>=33. Two of the four tests with SN<26 were located on the I-295(N) mainline. One was located on the I-295 (S) cloverleaf exit onto Suitland east, and the

Figure B29. This photo shows the interchange from I-295 NB.

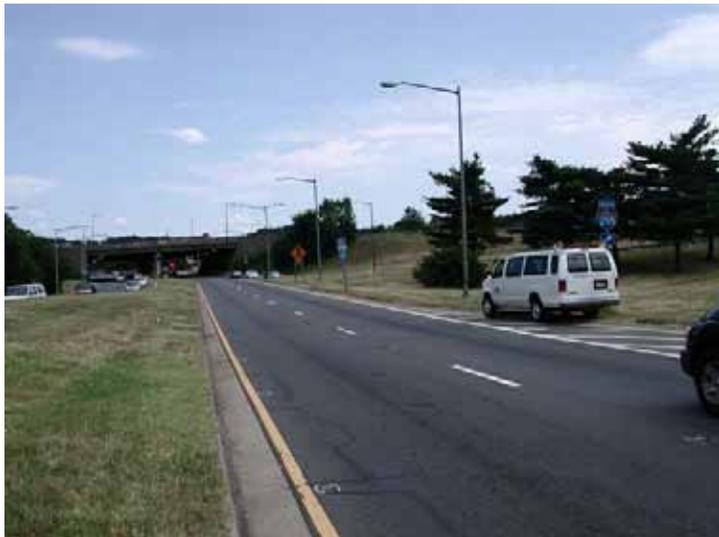
Figure B30. Taken from the median of the Suitland Parkway facing east, this photo shows the I-295 Interchange.

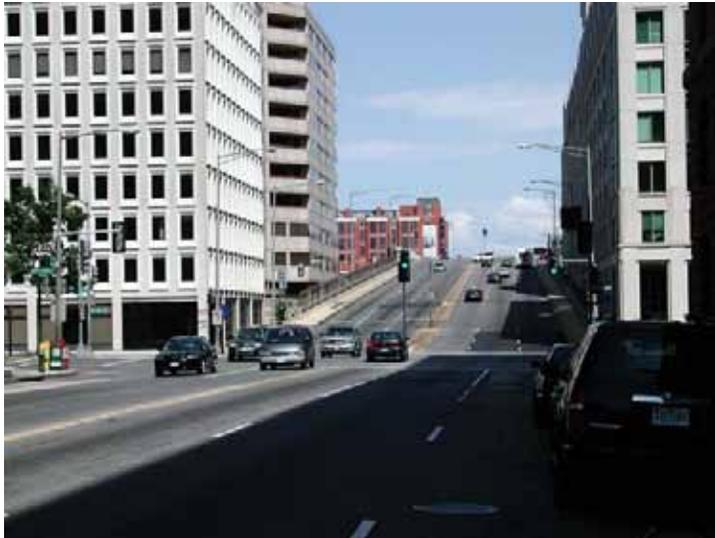
Skid resistance testing was performed on the intersection of H Street and North Capitol Street the night of July 25, 2009. This is a major intersection of two multi-lane roadways. Figures B33 & B34 are photographs that show the intersection from two angles. Table B9 shows the number of test results that occurred in each of the designated SN ranges. Figure B35 shows the percentage distribution of test results by SN range at this location. Four tests (22.2%) resulted in a SN<26 and 50.0% of the tests had an SN>=33. Two of the tests with SN<26 were located on eastbound H Street approaching N Capitol St. One each were also located on N Capitol Street approaching H Street from the north and south.

Figure B33. This photo shows the intersection of H St & N Capitol St form H St facing east.

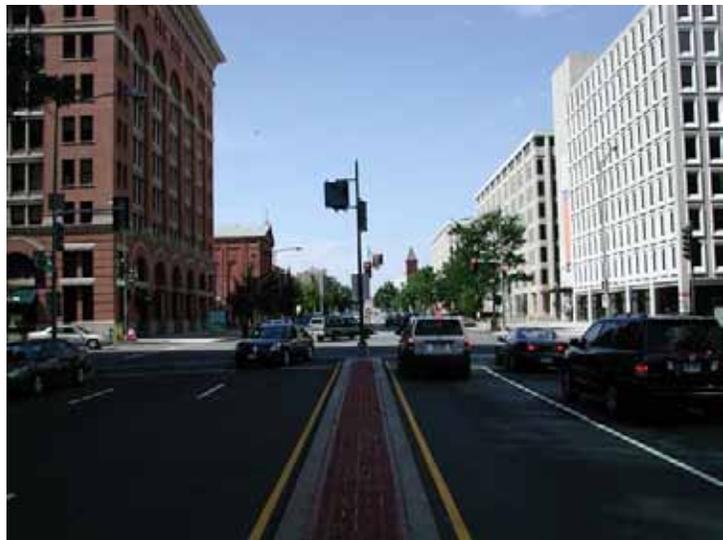
Figure B34. Taken from the median of N. Capitol Street facing north, this photo shows the intersection with H Street.

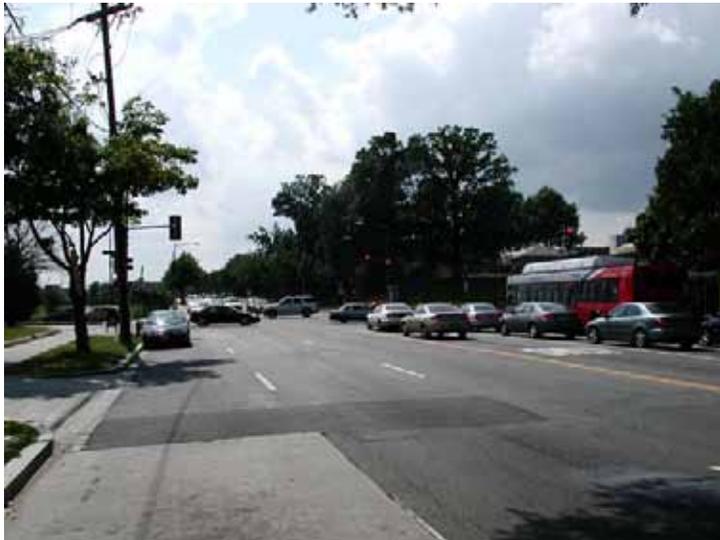
Skid resistance testing was performed on the intersection of Michigan Avenue and North Capitol Street the night of July 23, 2009. This is a major intersection of two multi-lane roadways. Figures B37 & B38 are photographs that show the intersection from two angles. Table B10 shows the number of test results that occurred in each of the designated SN ranges. Figure B39 shows the percentage distribution of test results by SN range at this location. One test (5.6%) resulted in a SN<26 and 94.4% of the tests had an SN>=33. The only skid resistance test that yielded a SN<26 was located on northbound North Capitol Street. Figure B40 is an aerial image of the intersection showing a color coded dot which represents the start point of each skid test.

Figure B37. This photo shows the intersection of Michigan Ave & N Capitol St from Michigan Ave facing west.

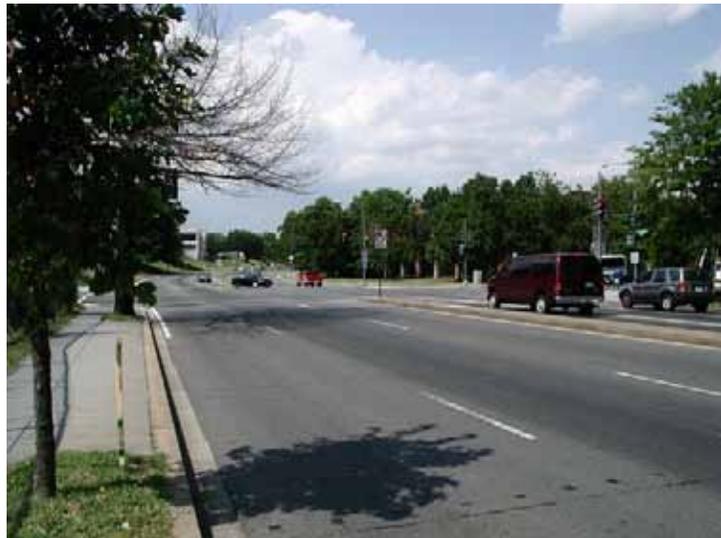
Figure B38. Taken from N. Capitol Street facing north, this photo shows the intersection with Michigan Ave.

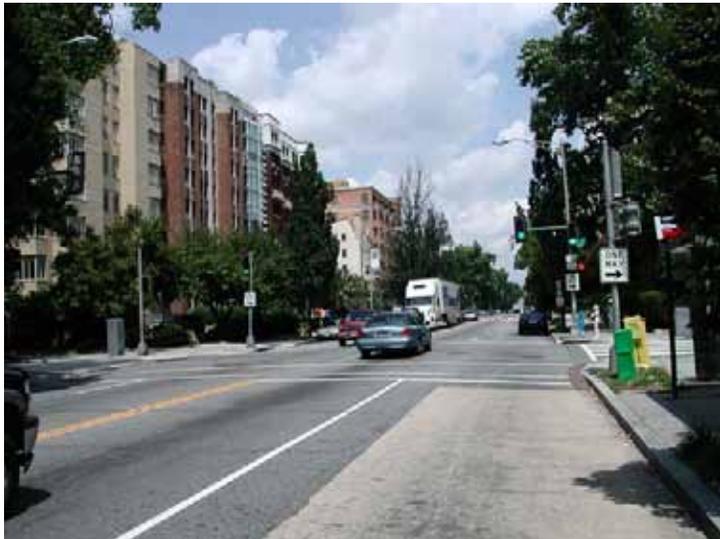
Skid resistance testing was performed on the intersection of 16<sup>th</sup> Street and Q Street the night of July 24, 2009. This is a major intersection of one multi-lane road (16<sup>th</sup> St) and a one-way road (Q St) traveling west to east. Figures B41 & B42 are photographs that show the intersection from two angles. Table B11 shows the number of test results that occurred in each of the designated SN ranges. Figure B43 shows the percentage distribution of test results by SN range at this location. None of the test results had an SN<26 and 66.7% of the tests had an SN>=33. Figure B44 is an aerial image of the intersection showing a color coded dot which represents the start point of each skid test.

Figure B41. This photo shows the intersection of 16<sup>th</sup> St & Q St from 16<sup>th</sup> St facing north and shows the “One Way” sign for Q St.

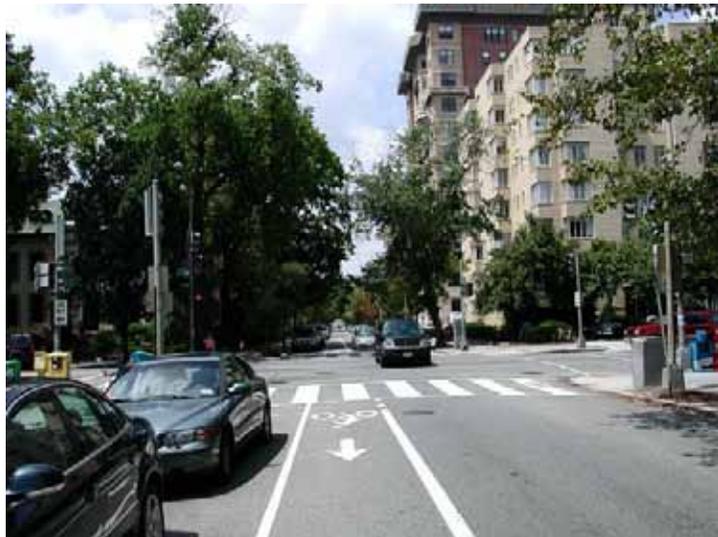
Figure B42. This photo shows the intersection of 16<sup>th</sup> St & Q St from Q St facing west.

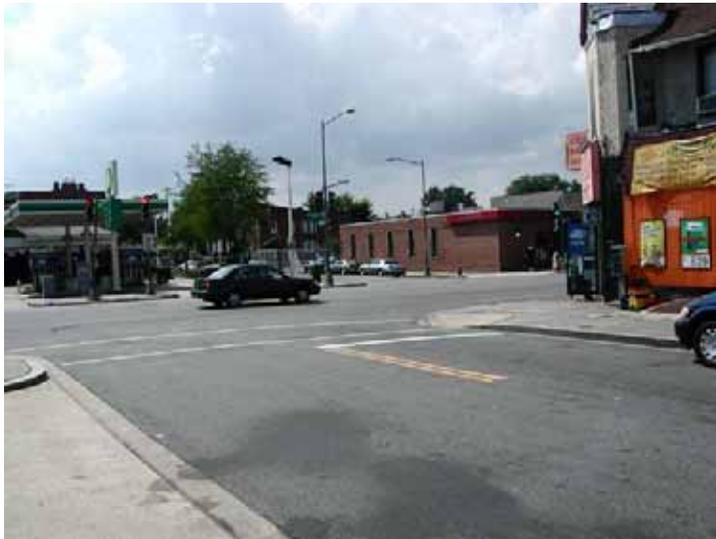
Skid resistance testing was performed on the intersection of Georgia Avenue and Park Road the night of July 23, 2009. Park Road is offset on each side of Georgia Avenue. Figures B45 & B46 are photographs that show the intersection from two angles. Table B12 shows the number of test results that occurred in each of the designated SN ranges. Figure B47 shows the percentage distribution of test results by SN range at this location. One test (8.3%) resulted in a SN<26 and 83.3% of the tests had an SN>=33. The only skid resistance test that yielded a SN below 26 was located on eastbound Park Road. Figure B48 is an aerial image of the intersection showing a color coded dot which represents the start point of each skid test.

Figure B45. This photo shows the intersection of Georgia Ave & Park Rd from Park Rd facing west.

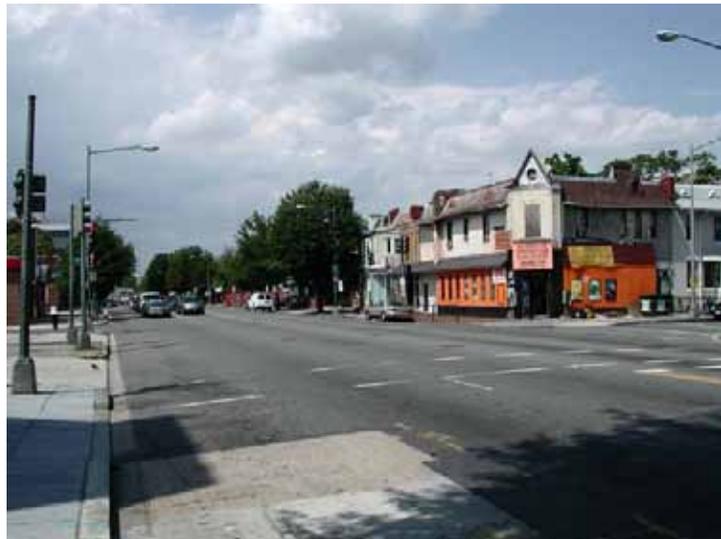
Figure B46. This photo shows the intersection of Georgia Ave & Park Rd from Georgia Ave facing north.

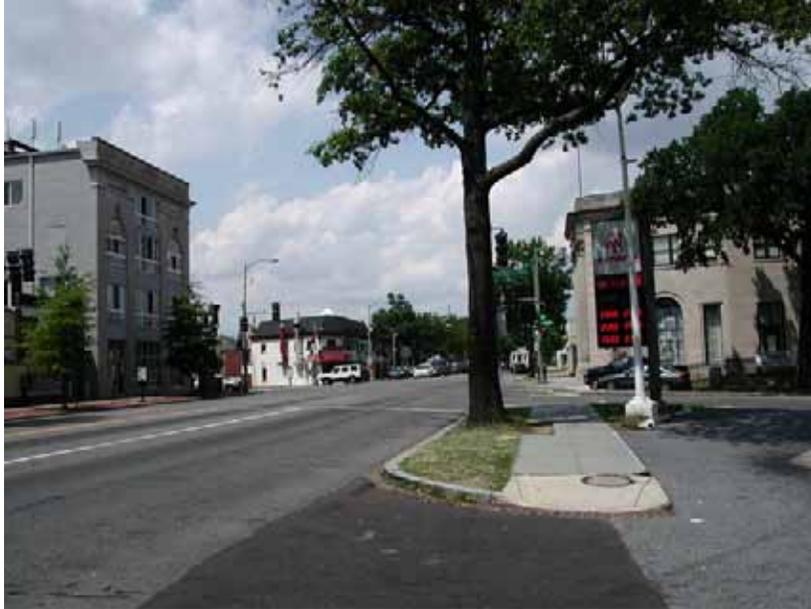
Skid resistance testing was performed on the intersection of Georgia Avenue and Missouri Avenue the night of July 22, 2009. This is a major intersection of two multi-lane roadways. Missouri Avenue is offset on each side of Georgia Avenue. Figures B51 & B50 are photographs that show the intersection from two angles. Table B13 shows the number of test results that occurred in each of the designated SN ranges. Figure B51 shows the percentage distribution of test results by SN range at this location. Two tests (12.5%) resulted in a SN<26 and 50.0% of the tests had an SN>=33. One of the skid resistance tests that yielded a SN of less than 26 was

Figure B49. This photo shows the intersection of Georgia Ave & Missouri Ave as seen from Georgia Ave facing north.

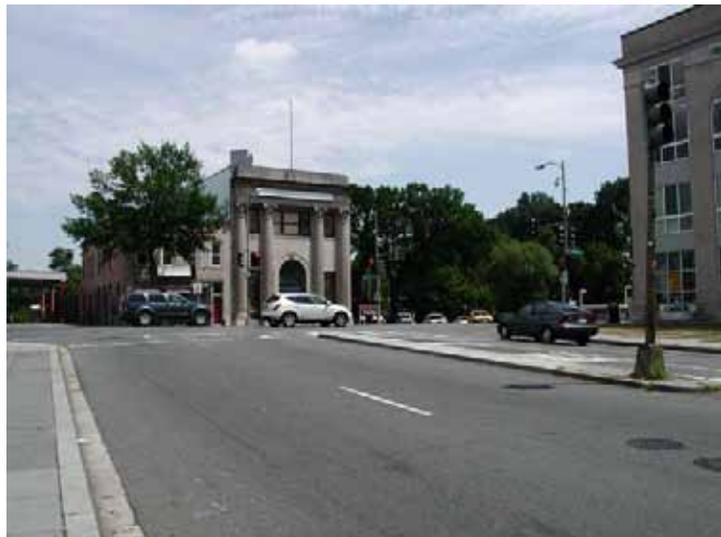
Figure B50. This photo shows the intersection of Georgia Ave & Missouri Ave as seen from Missouri Ave facing west.

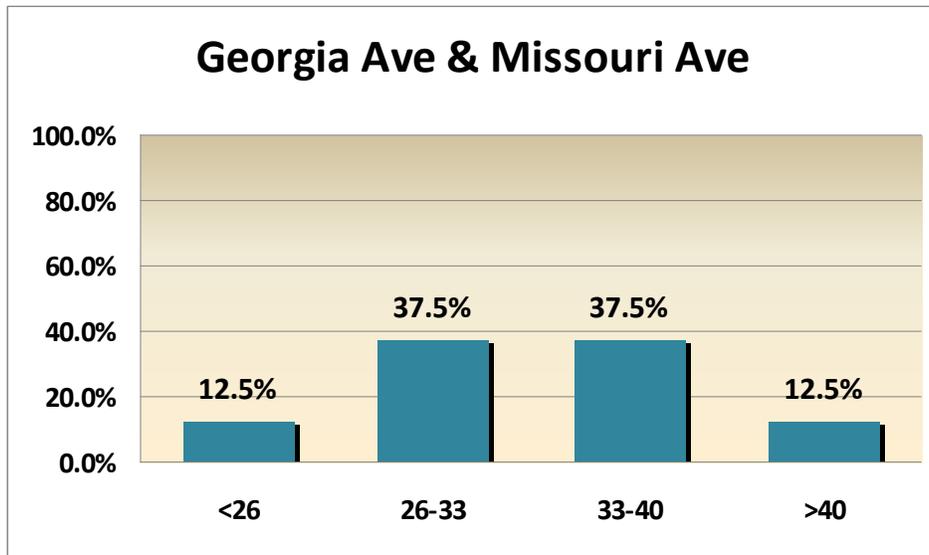
Figure B51 Distribution of Test Results by SN Range, Percentage

located on southbound Georgia Avenue and one was located on westbound Missouri Avenue. Figure B52 is an aerial image of the intersection showing a color coded dot which represents the start point of each skid test.

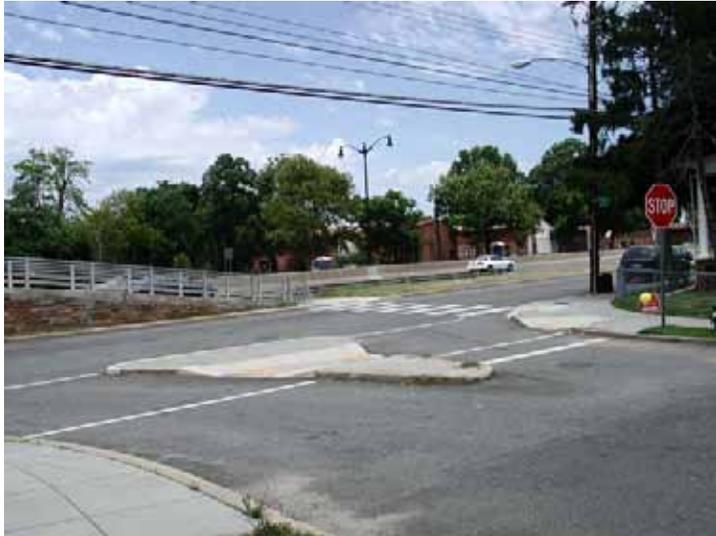
Skid resistance testing was performed on the intersection of Kenilworth Avenue and Polk Street the night of July 26, 2009. This is a T intersection of a two-lane road (Polk St) and a one-way, one-lane, road (Kenilworth Ave). Figures B53 & B54 are photographs that show the intersection from two angles. Table B14 shows the number of test results that occurred in each of the designated SN ranges. Figure B55 shows the percentage distribution of test results by SN range at this location. None of the test results had an SN<26 and 100.0% of the tests had an SN>=33. Figure B56 is an aerial image of the intersection showing a color coded dot which represents the start point of each skid test.

Figure B53. This photo shows the intersection of Kenilworth Ave & Polk St as seen from Polk St facing west.

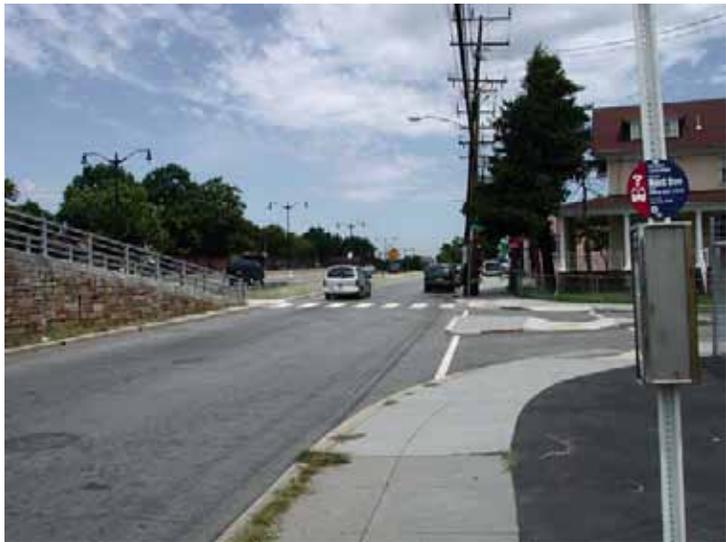
Figure B54. This photo shows the intersection of Kenilworth Ave & Polk St as seen from Kenilworth Ave facing north.

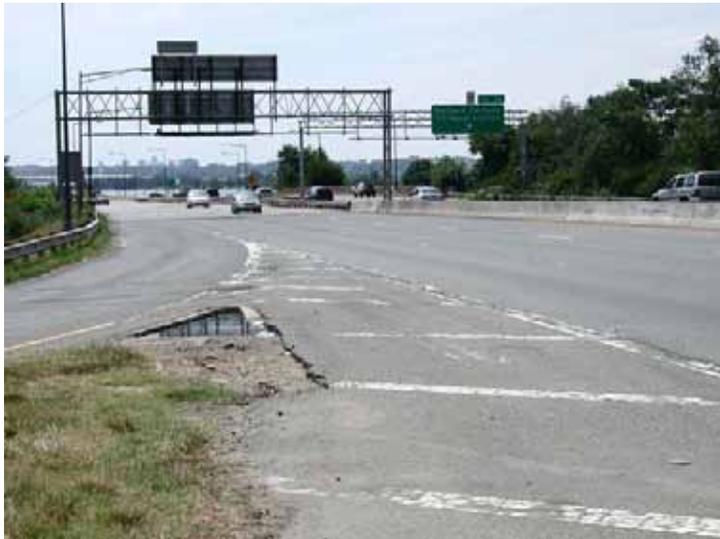
Figure B57. This photo shows the I-295 & Suitland Parkway Interchange as seen looking south along the northbound lanes of I-295.

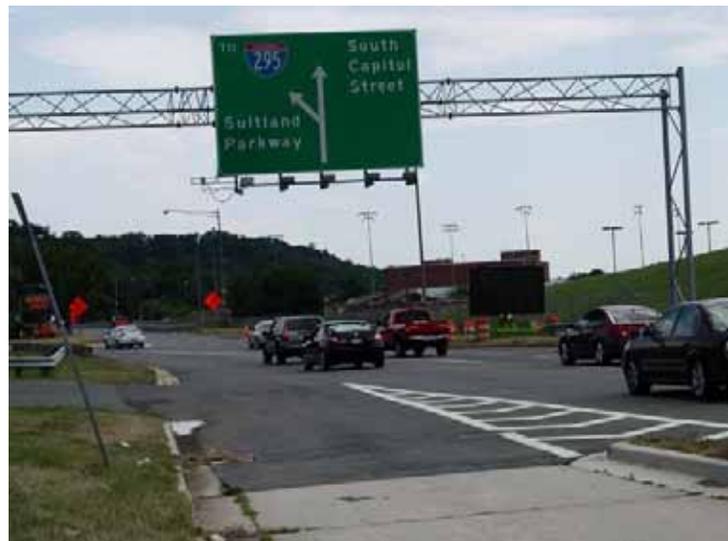
Figure B58. This photo shows the I-295 & Suitland Parkway Interchange as seen from Suitland Parkway facing west.

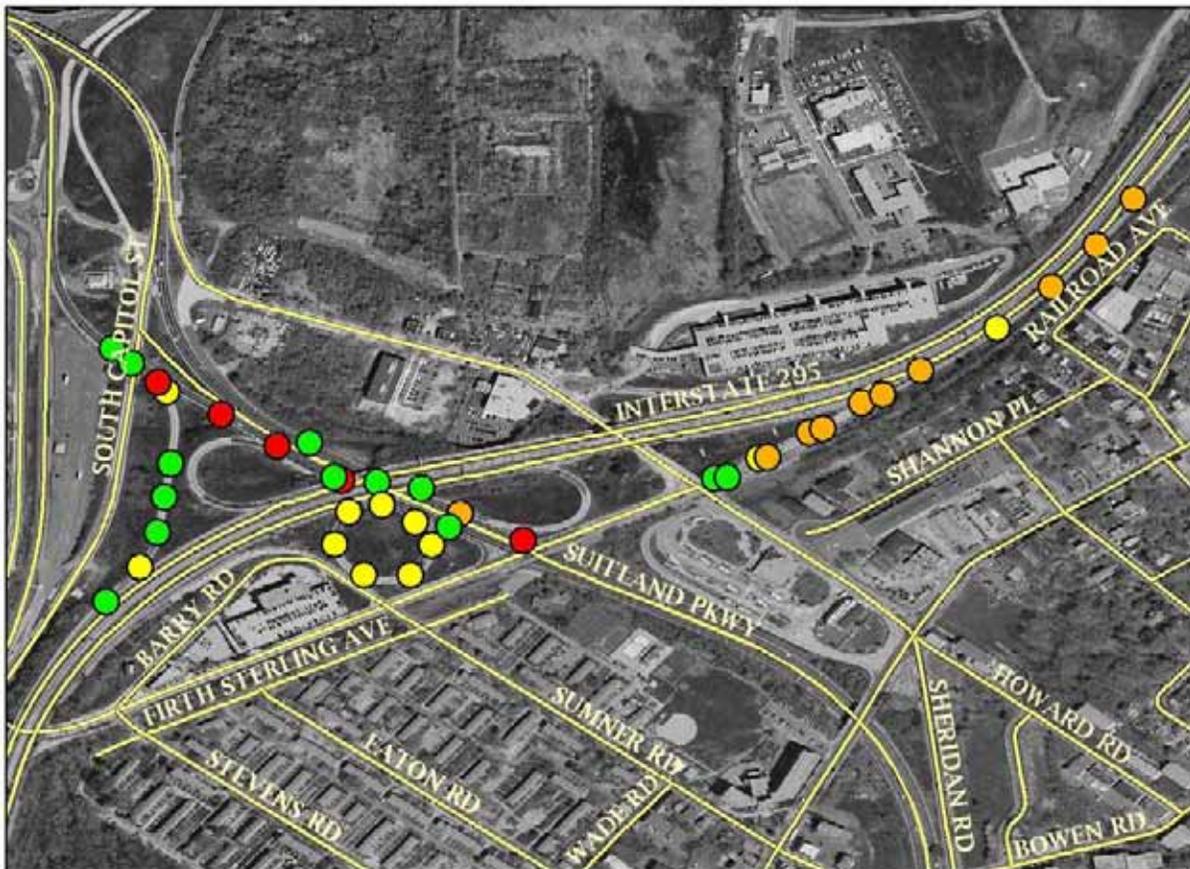
Figure B60 Aerial image of the test location color coded by SN Range.

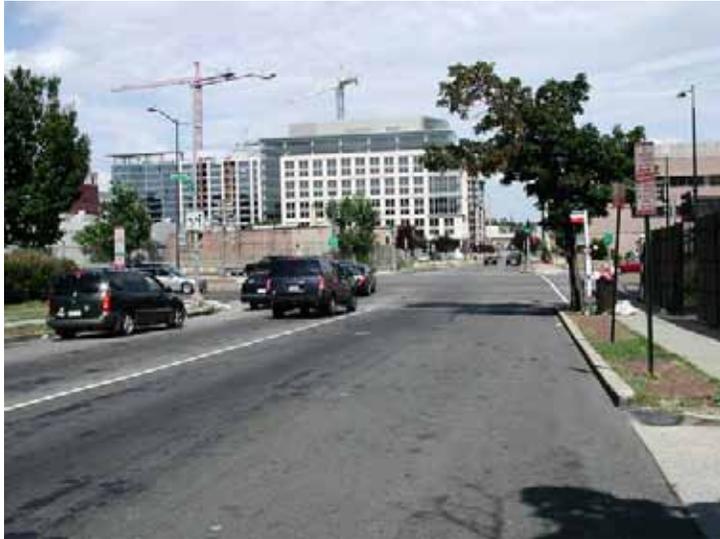
Figure B61. This photo shows the intersection of M St & N Capitol St as seen from M St facing east.

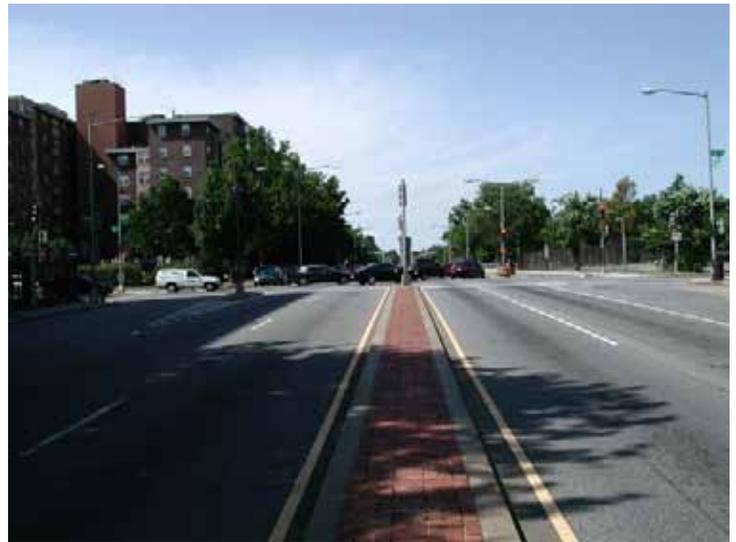
Figure B62. This photo shows the intersection of M St & N Capitol St as seen from N Capitol St facing north.

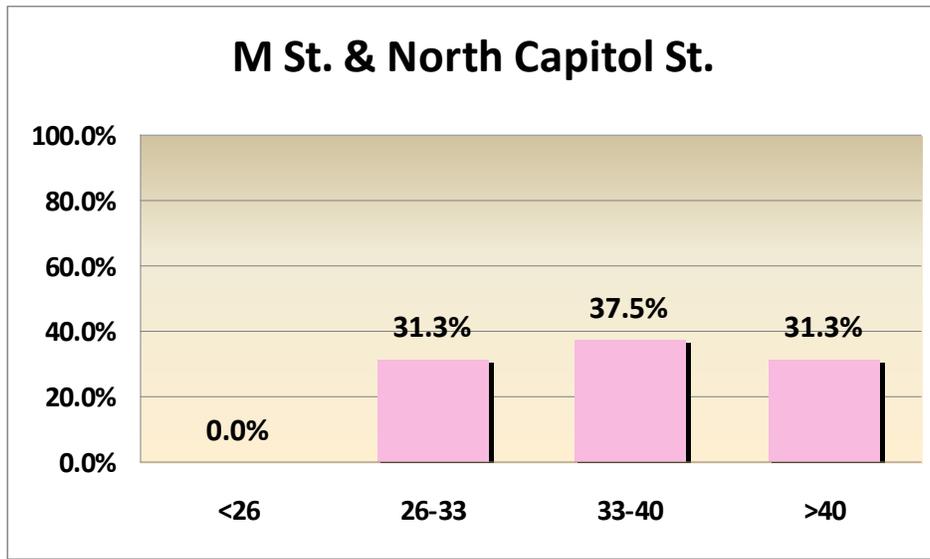
Figure B63 Distribution of Test Results by SN Range, Percentage

<b>M St &amp; N. Capitol St.</b>			
SN Values			
<b>&lt;26</b>	<b>26-33</b>	<b>33-40</b>	<b>&gt;40</b>
0	5	6	5
