**Final Report on  
District Wide  
Highway Safety Improvement Program (HSIP)  
Intersection Skid Resistance Testing**

**District Department of Transportation  
Infrastructure Project Management Administration  
Safety, Standards, and Quality Control Division**

**September 11, 2009**

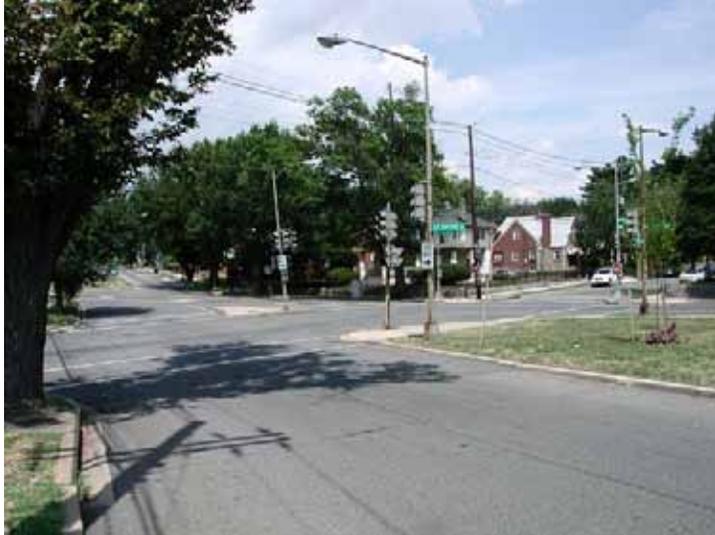
Figure B65. This photo shows the intersection of New Hampshire Ave & N Capitol St as seen from New Hampshire Ave facing west.

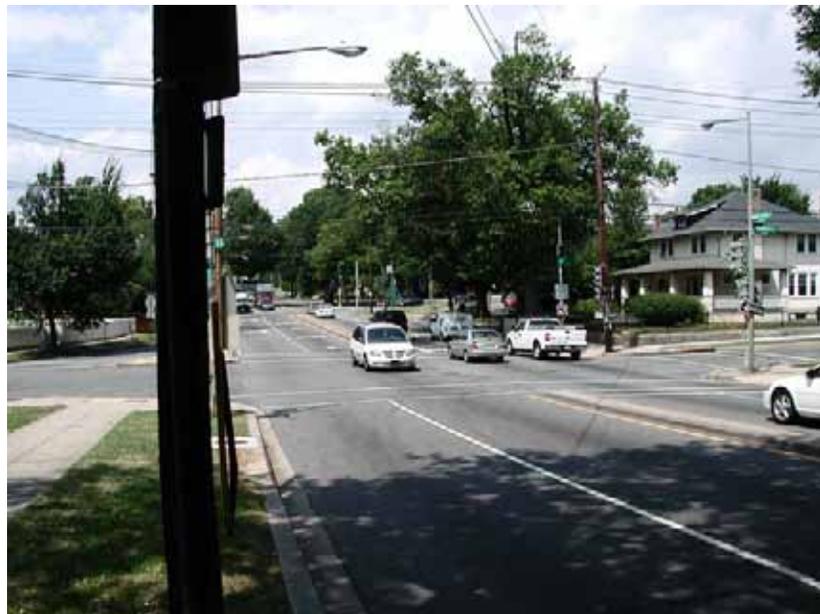
Figure B66. This photo shows the intersection of New Hampshire Ave & N Capitol St as seen from N Capitol St facing north.

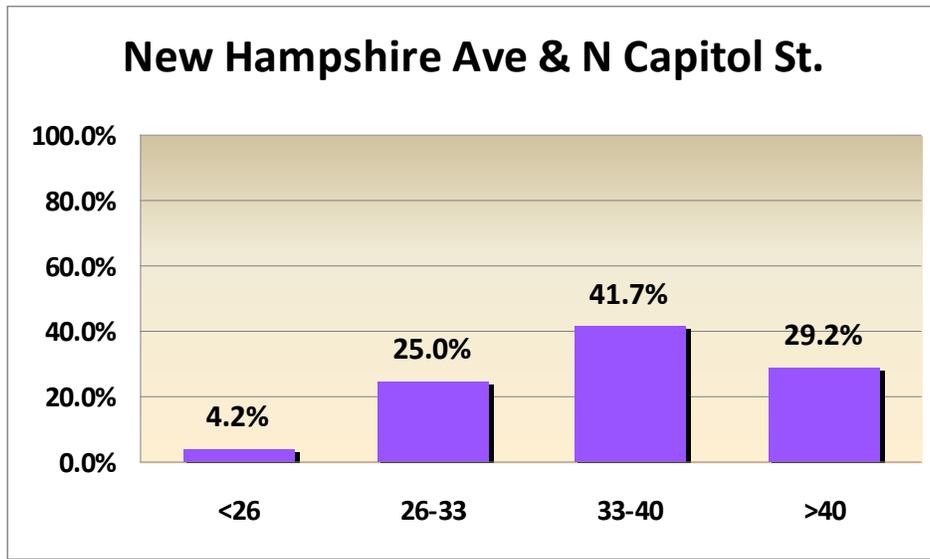
Figure B67 Distribution of Test Results by SN Range, Percentage

NH Ave & N Capitol St.			
SN Values			
<26	26-33	33-40	>40
1	6	10	7

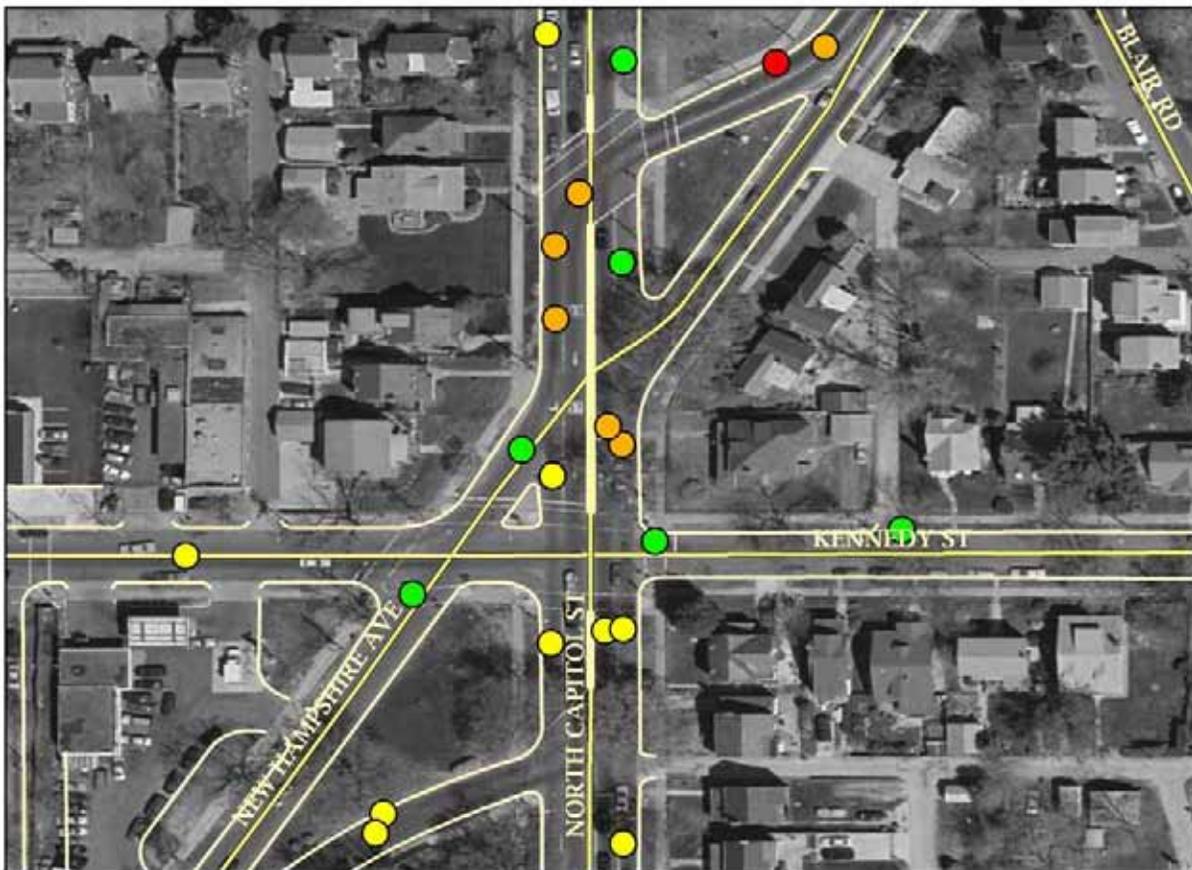
Figure B68 Aerial image of the test location color coded by SN Range.

only skid resistance test which yielded a SN below 26 was located on southbound New Hampshire Ave. Figure B68 is an aerial image of the intersection showing a color coded dot which represents the start point of each skid test.

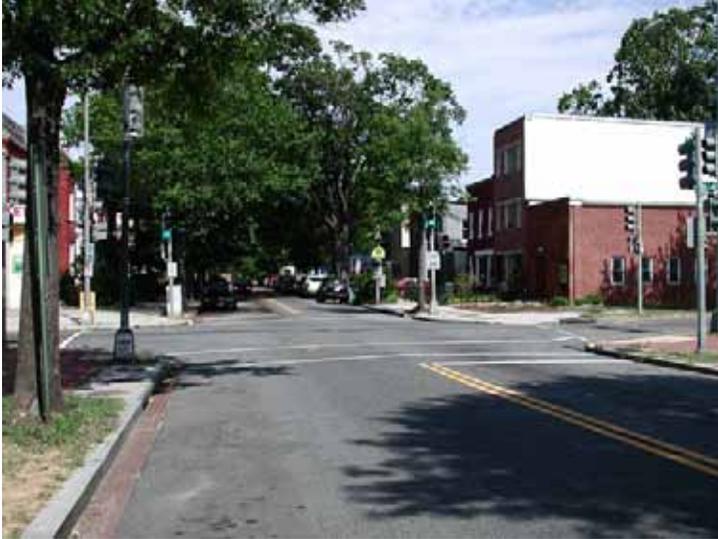
Figure B69. This photo shows the intersection of 1<sup>st</sup> St & P St as seen from P St facing east.

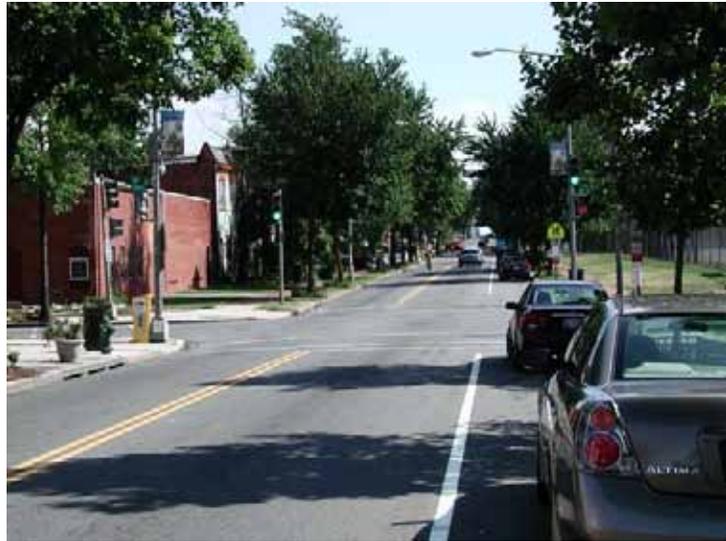
Figure B70. This photo shows the intersection of 1<sup>st</sup> ST & P St as seen from 1<sup>st</sup> St facing south.

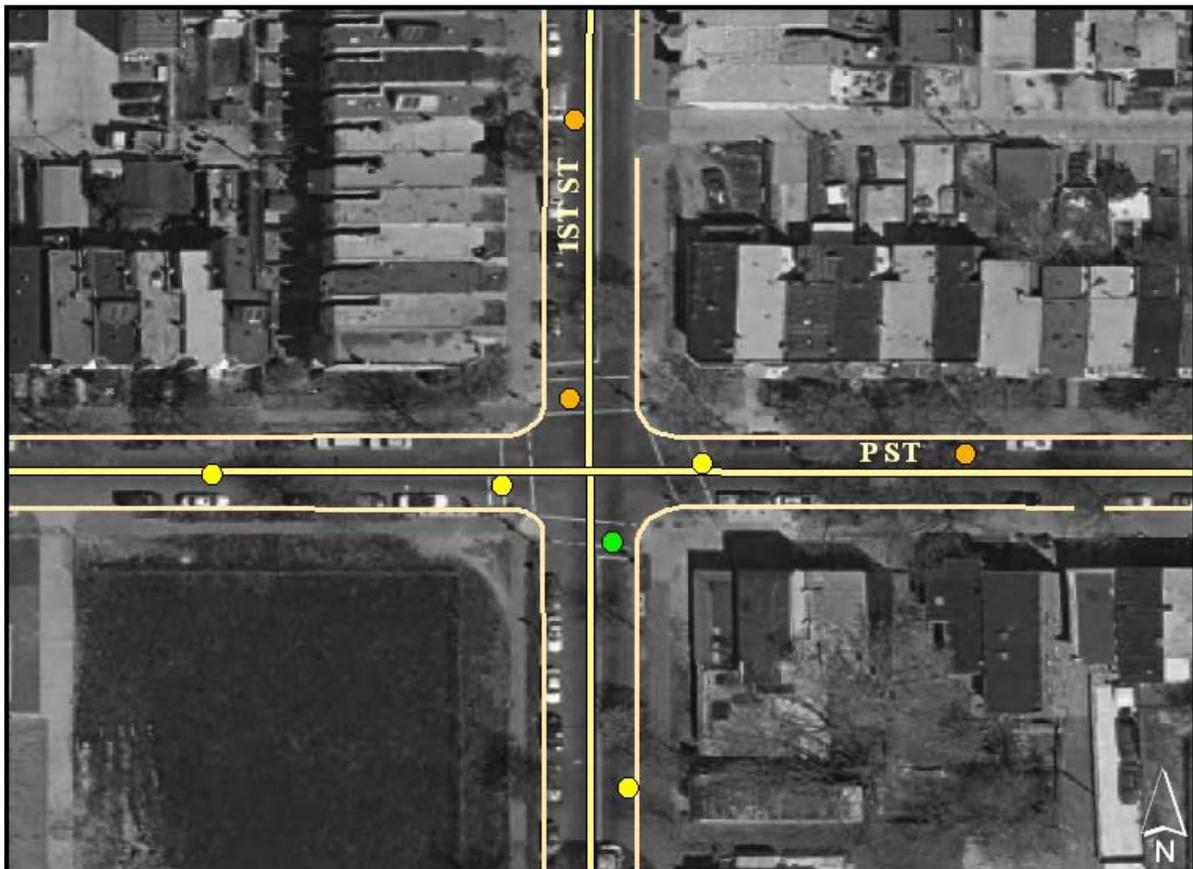
Figure B72 Aerial image of the test location color coded by SN Range.

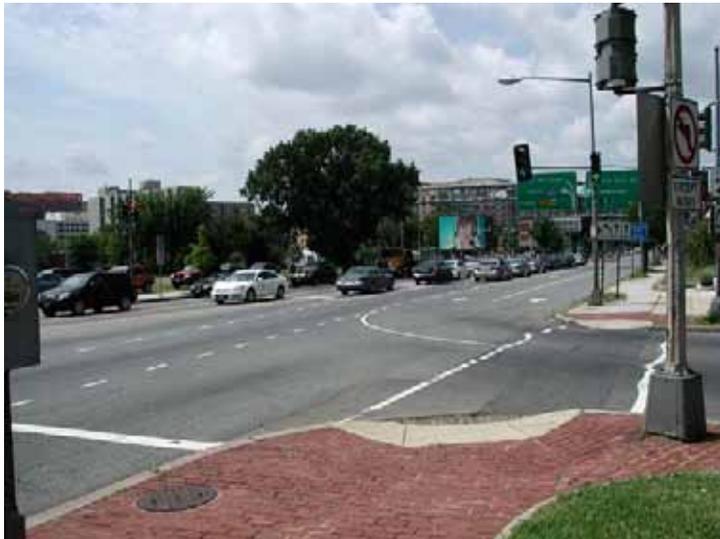
Figure B73. This photo shows the intersection of 3<sup>rd</sup> St & New York Ave as seen from the corner of 3<sup>rd</sup> ST facing west.

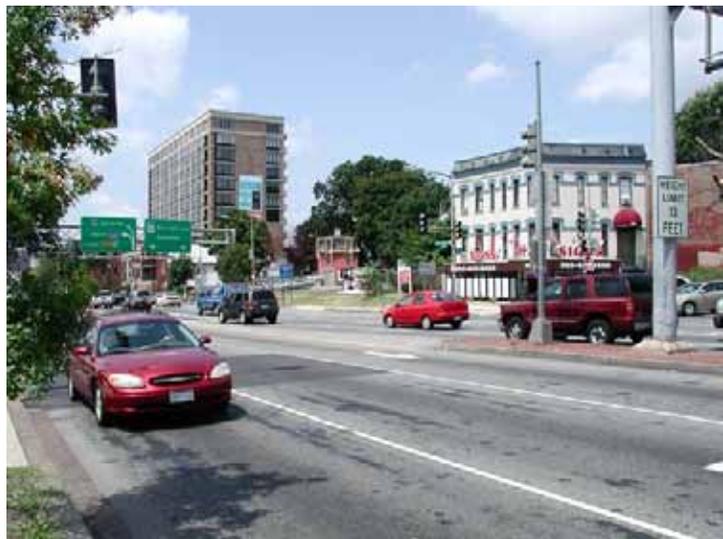
Figure B74. This photo shows the intersection of 3<sup>rd</sup> St & New York Ave as seen from the south side of New York Ave facing west.

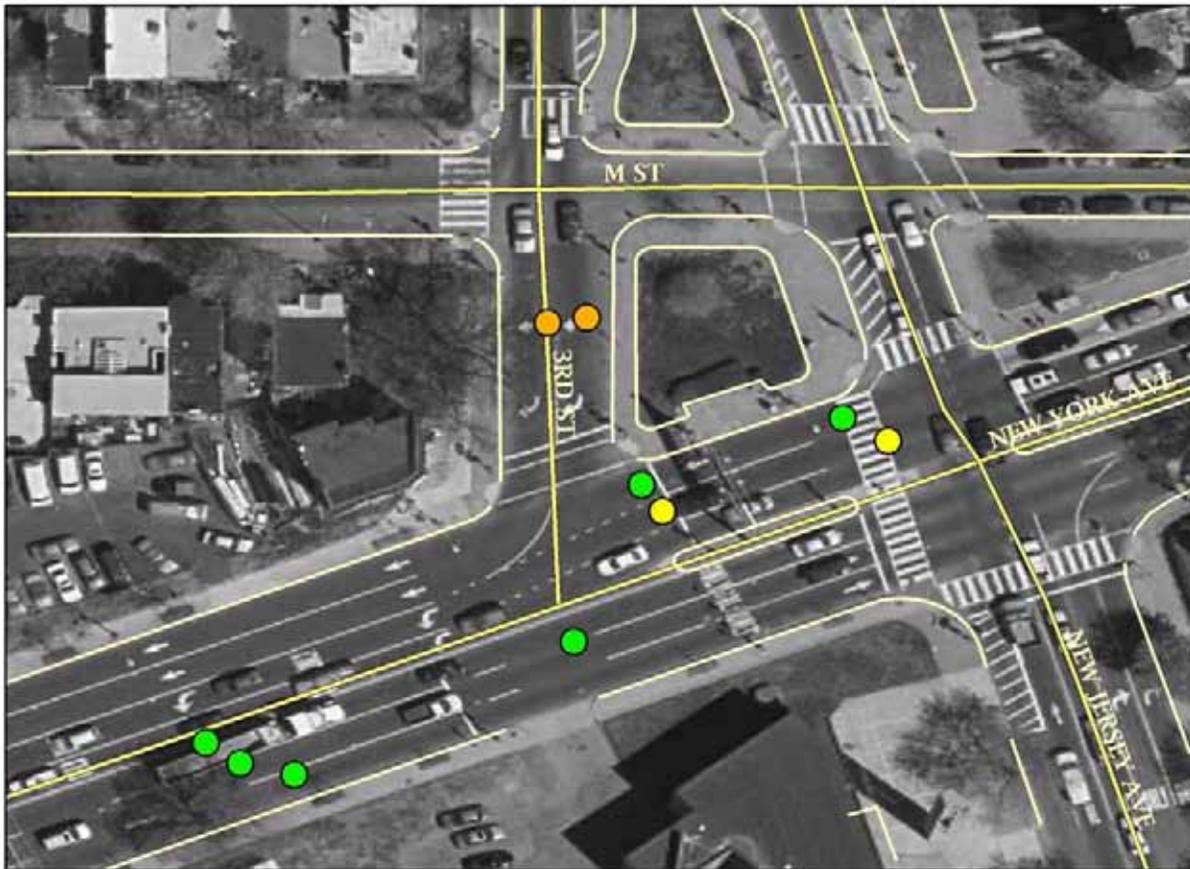
Figure B76 Aerial image of the test location color coded by SN Range.

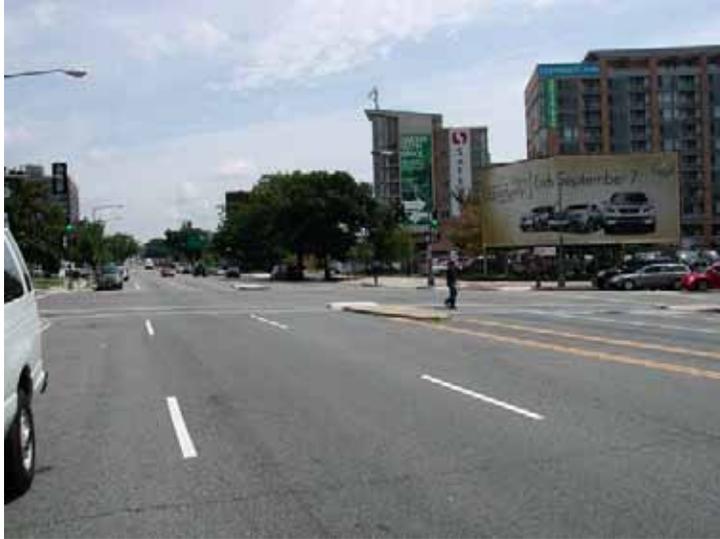
Figure B77. This photo shows the intersection of 6<sup>th</sup> St & New York Ave as seen from New York Ave facing east.

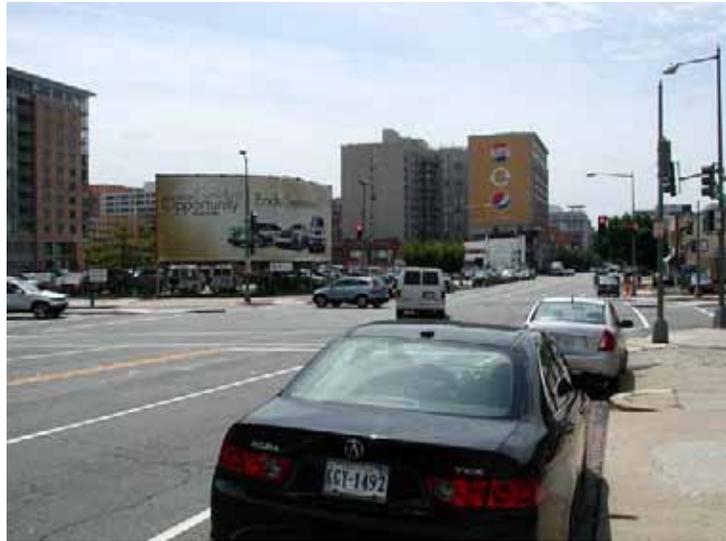
Figure B78. This photo shows the intersection of 6<sup>th</sup> St & New York Ave as seen from 6<sup>th</sup> ST facing south.

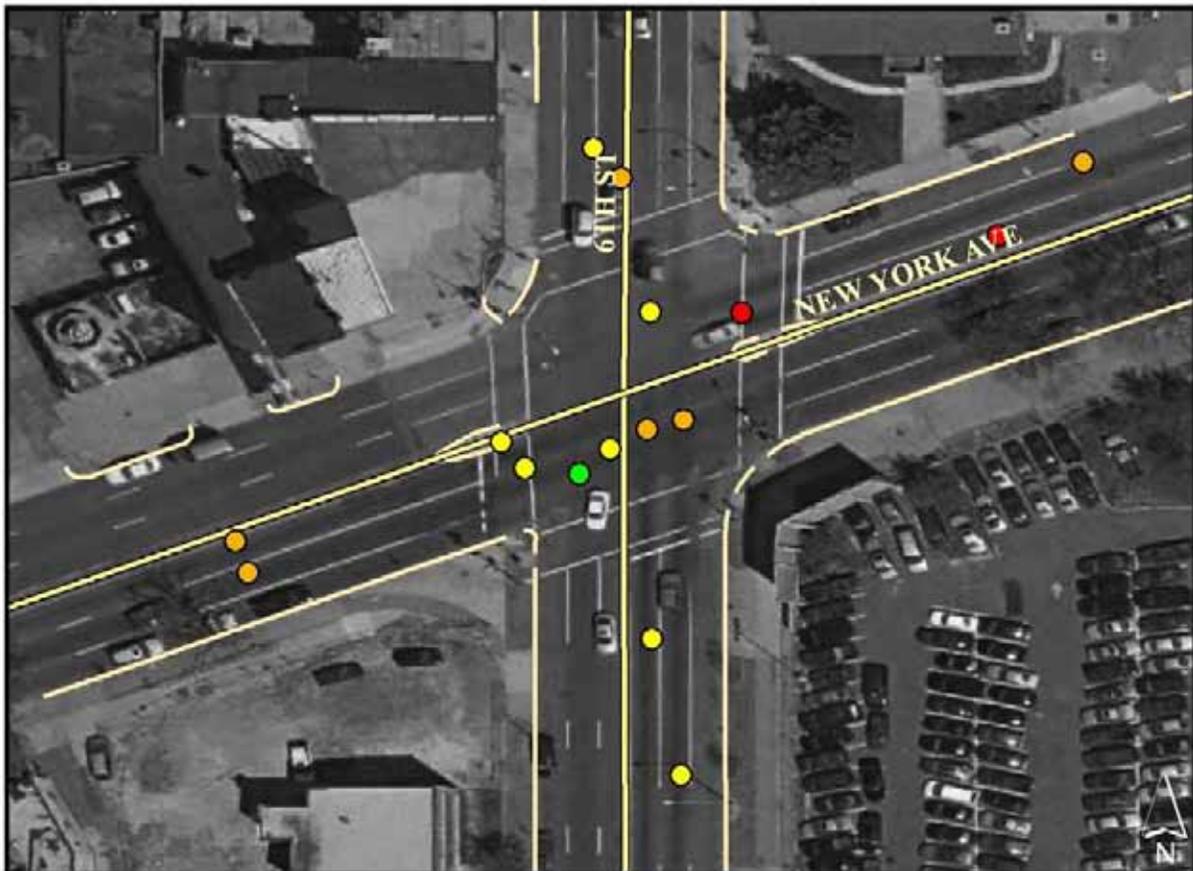
Figure B80 Aerial image of the test location color coded by SN Range.

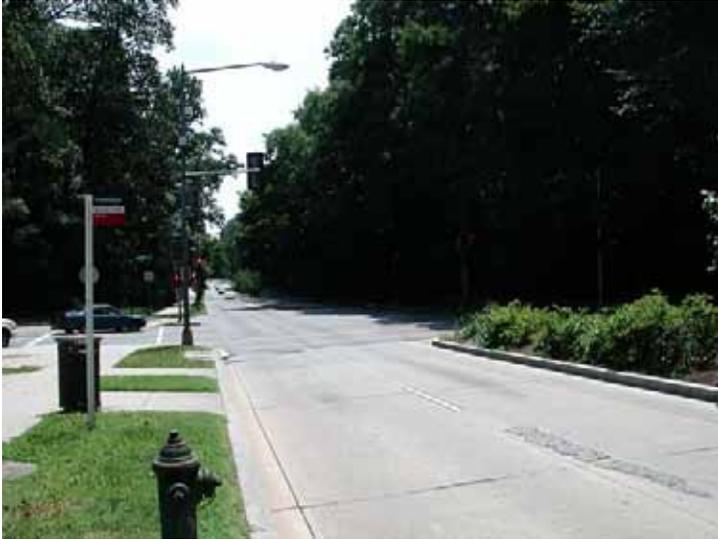
Figure B81. This photo shows the intersection of 16<sup>th</sup> St & Alaska Ave as seen from 16<sup>th</sup> St facing south.

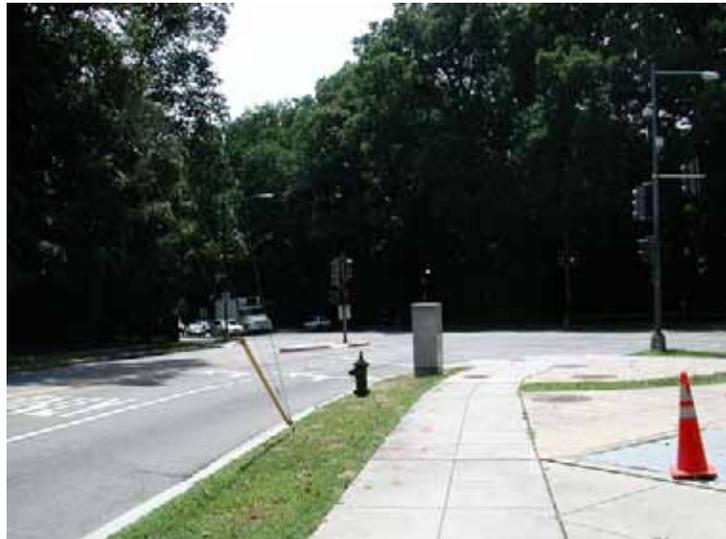
Figure B82. This photo shows the intersection of 16<sup>th</sup> St & Alaska Ave as seen from Alaska Ave facing southwest.

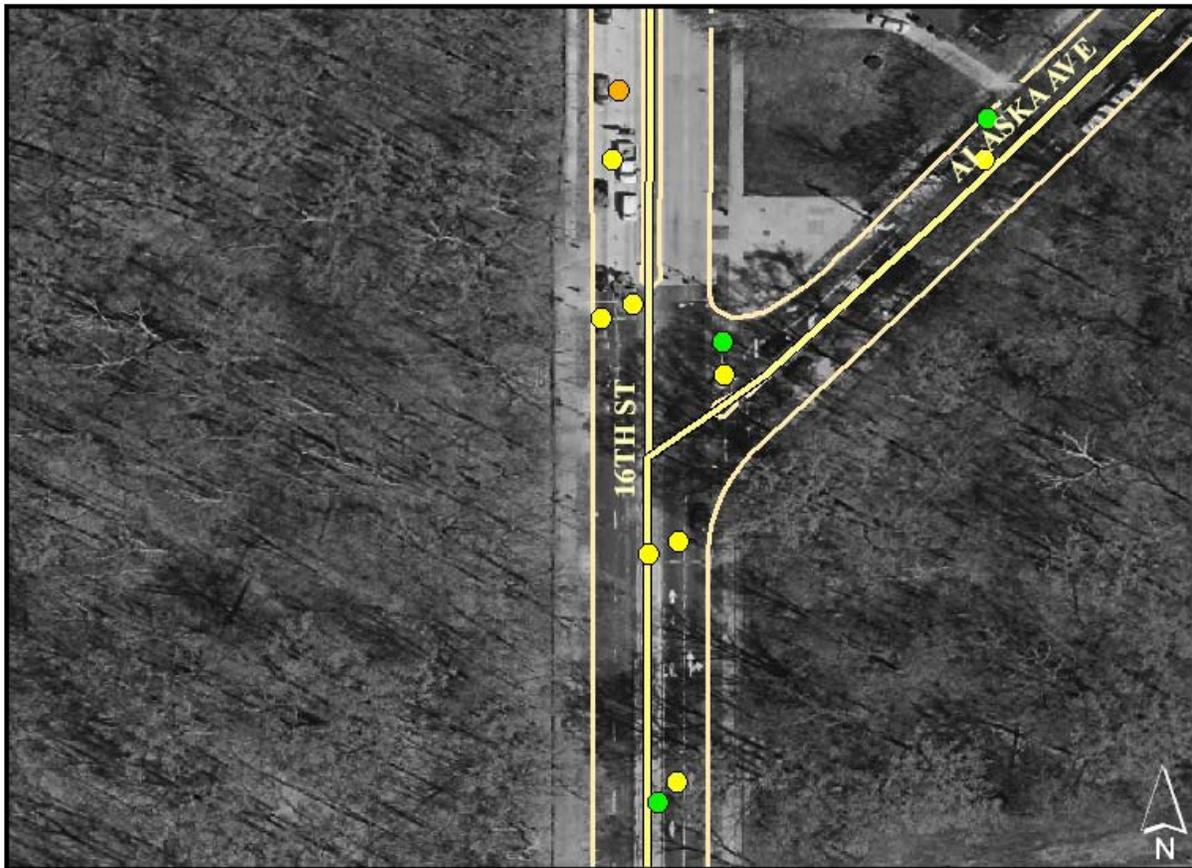
Figure B84 Aerial image of the test location color coded by SN Range.

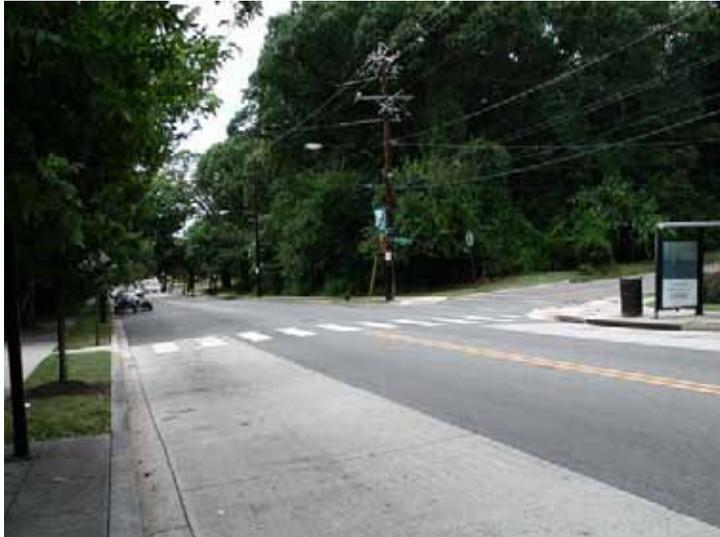
Figure B85. This photo shows the intersection of Good Hope Rd & Altamont Pl as seen from Good Hope Rd facing west.

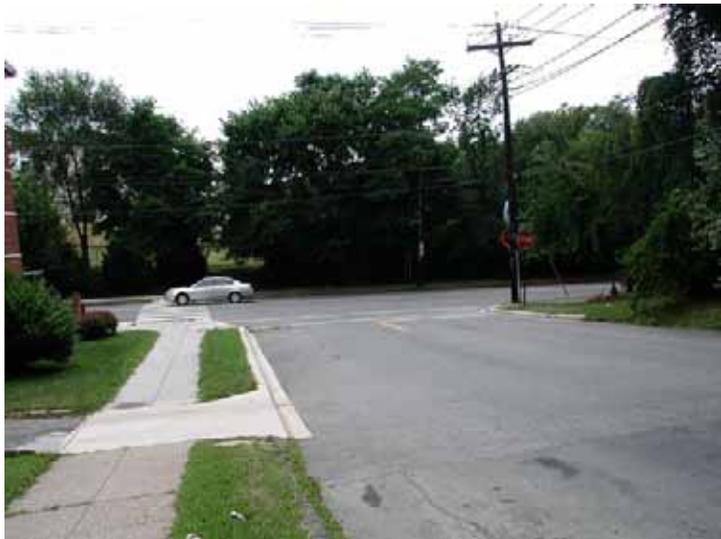
Figure B86. This photo shows the intersection of Good Hope Rd & Altamont Pl as seen from Altamont Pl facing south.

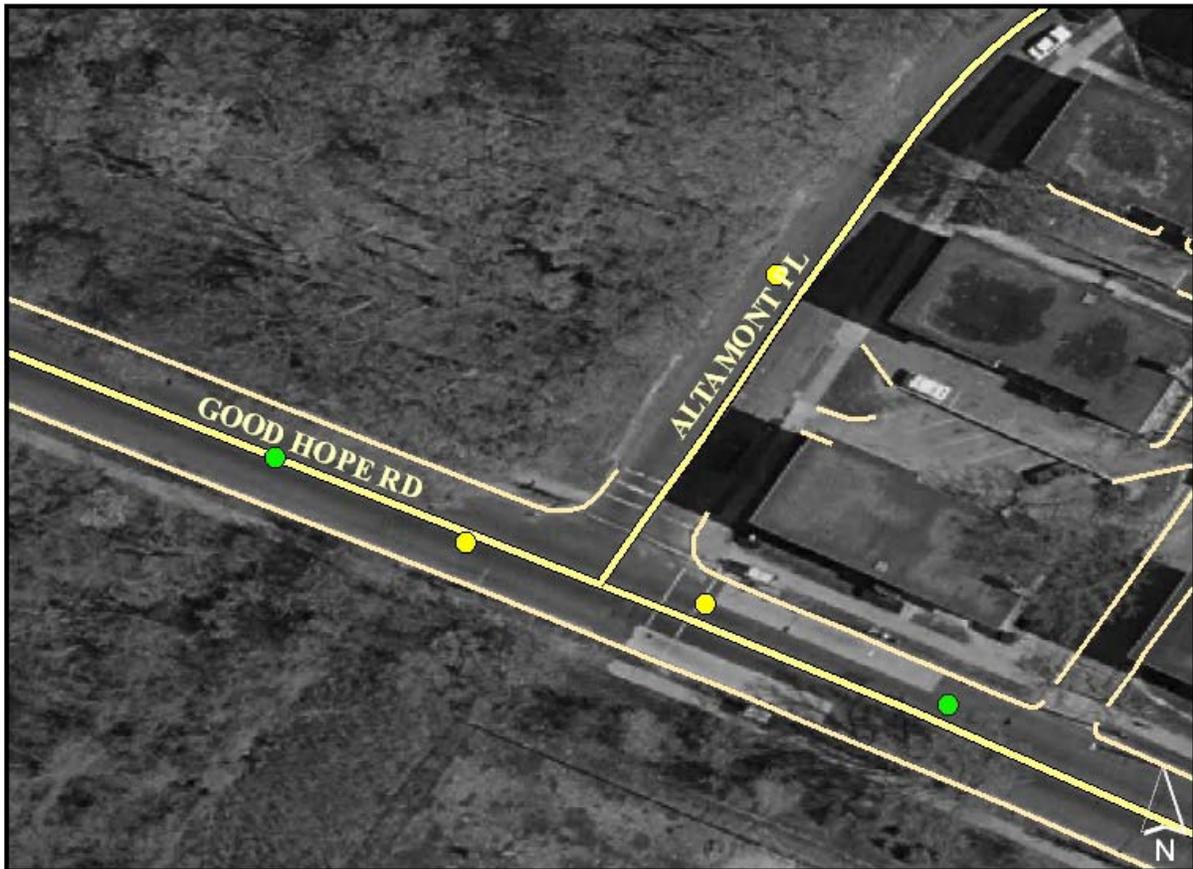
Figure B88 Aerial image of the test location color coded by SN Range.

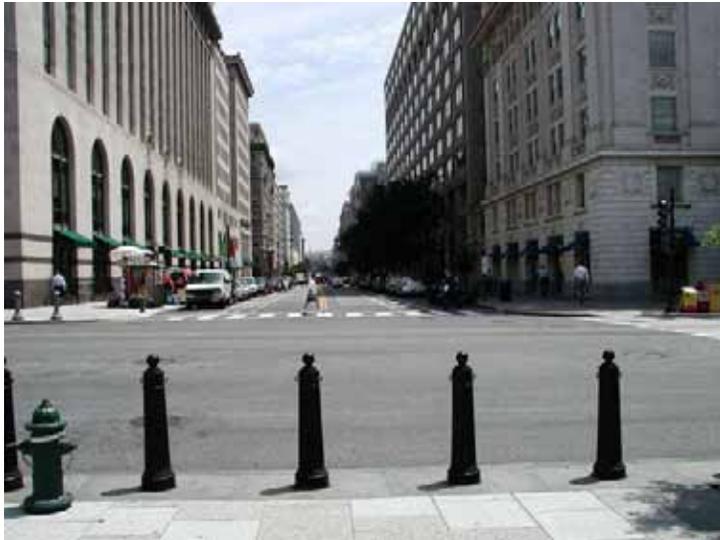
Figure B89. This photo shows the intersection of 15<sup>th</sup> St & G St as seen from 15<sup>th</sup> St facing east down G St.

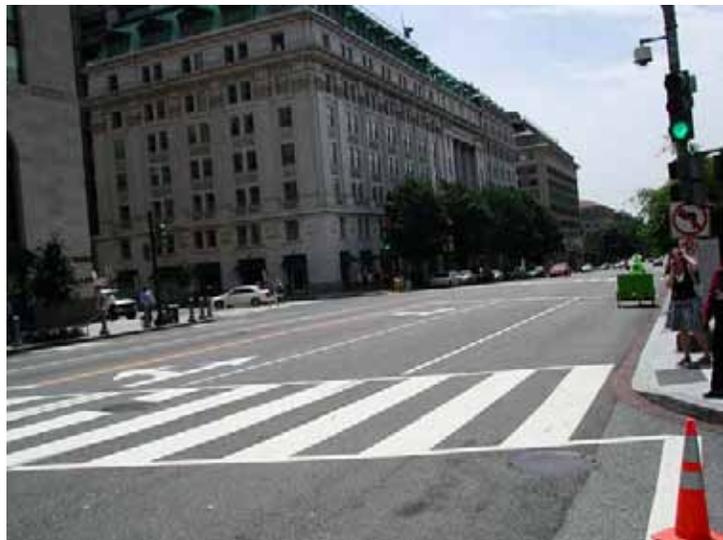
Figure B90. This photo shows the intersection of 15<sup>th</sup> St & G St as seen from 15<sup>th</sup> St facing south.

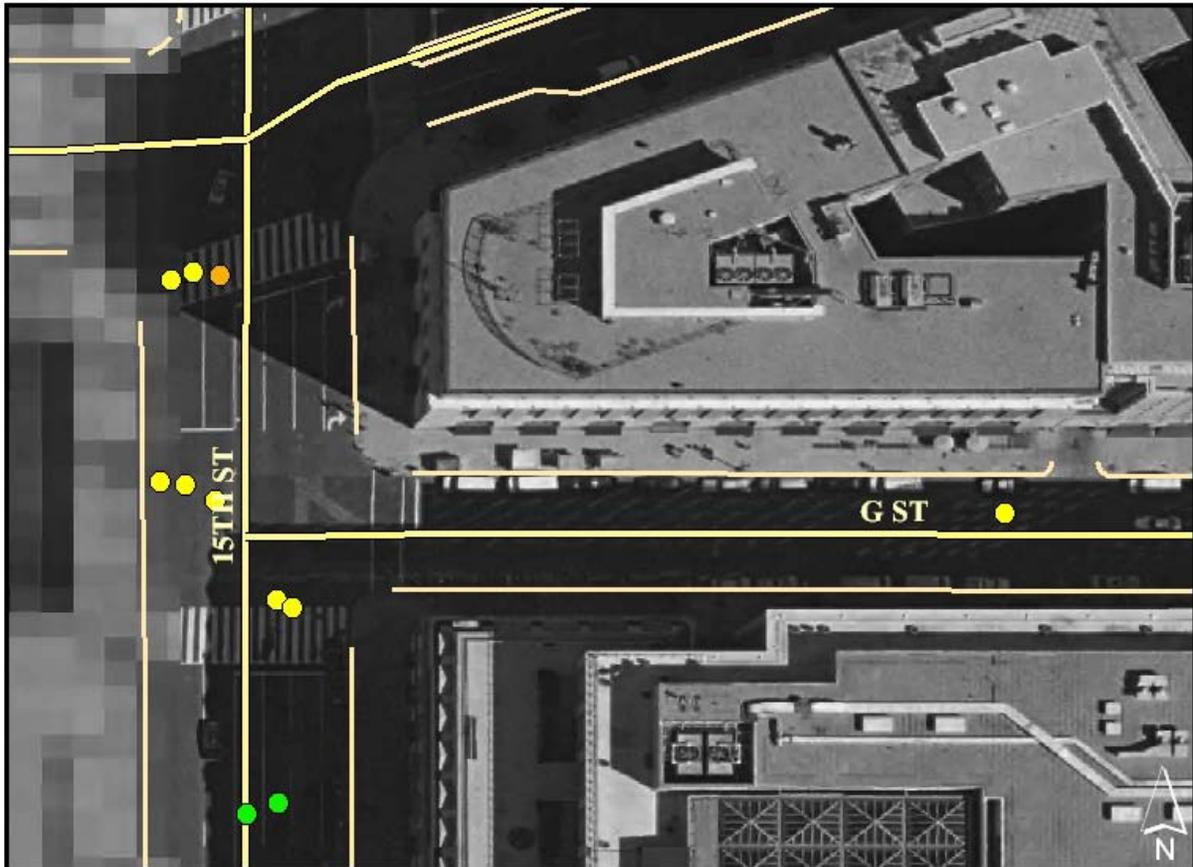
Figure B92 Aerial image of the test location color coded by SN Range.

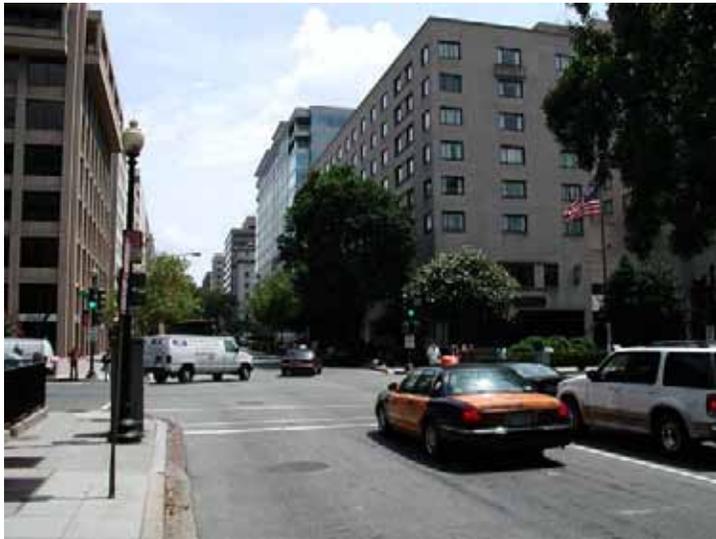
Figure B93. This photo shows the intersection of 16<sup>th</sup> St & L St as seen from L St facing east. L St is an eastbound, one way, street.

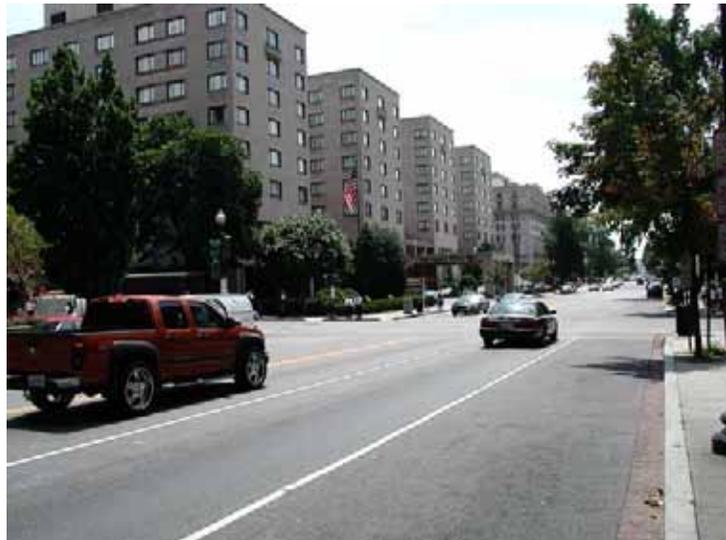
Figure B94. This photo shows the intersection of 16<sup>th</sup> St & L St as seen from 16<sup>th</sup> St facing south.

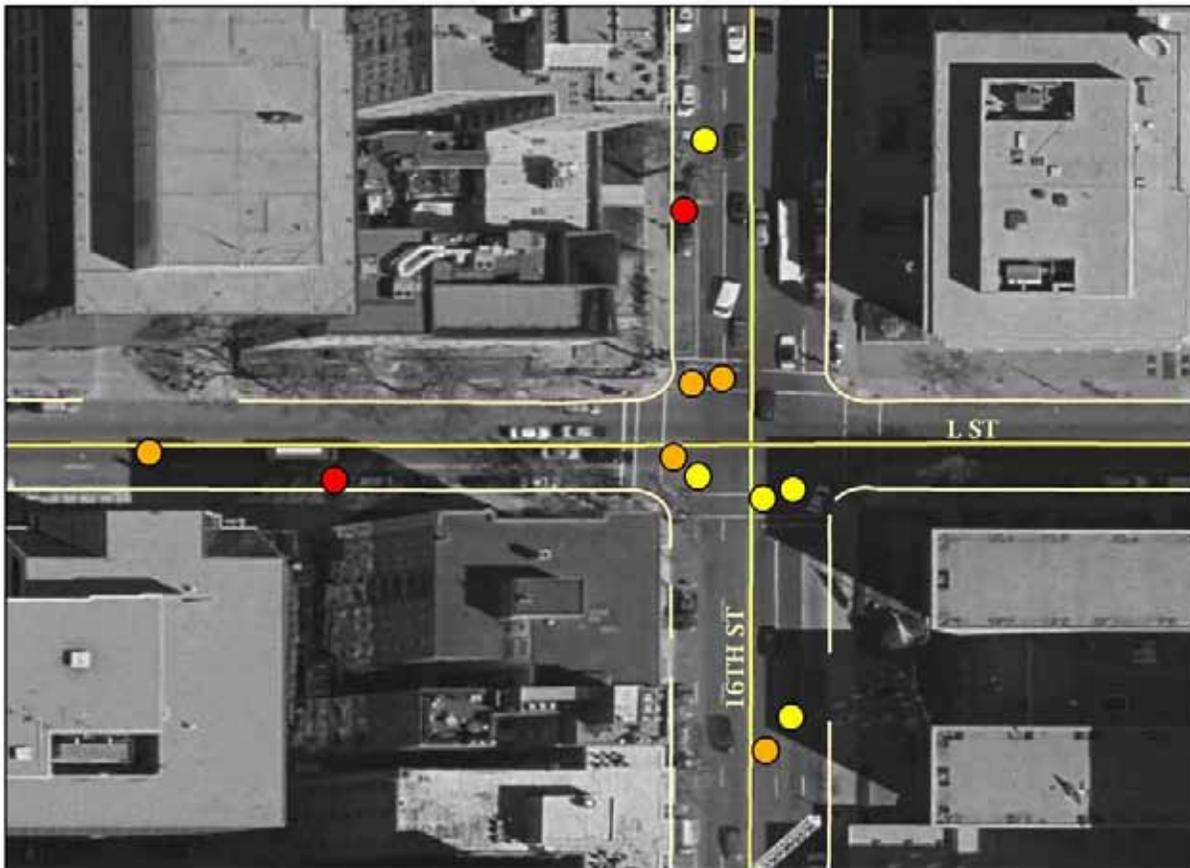
Figure B96 Aerial image of the test location color coded by SN Range.

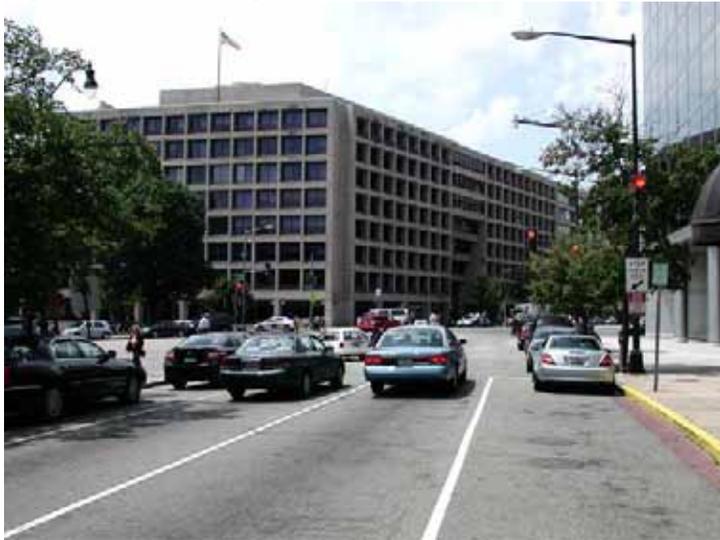
Figure B97. This photo shows the intersection of 21<sup>st</sup> St & Pennsylvania Ave as seen from Pennsylvania Ave facing west.

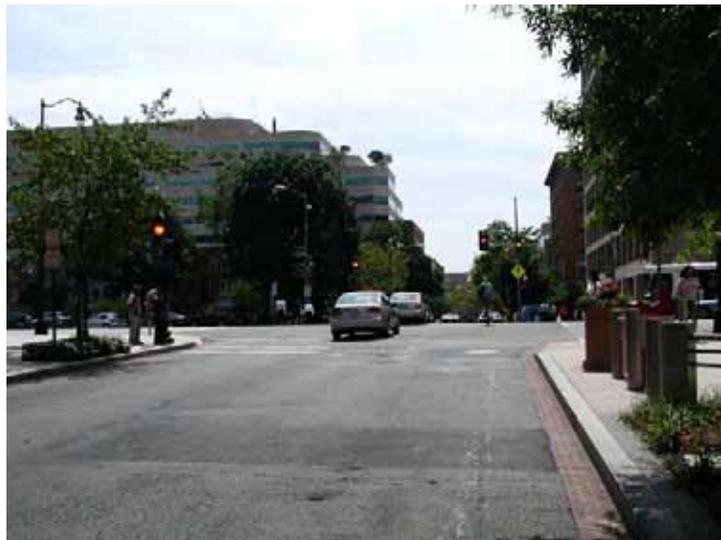
Figure B98. This photo shows the intersection of 21<sup>st</sup> St & Pennsylvania Ave as seen from 21<sup>st</sup> St facing south. 21<sup>st</sup> St is a one way street southbound.

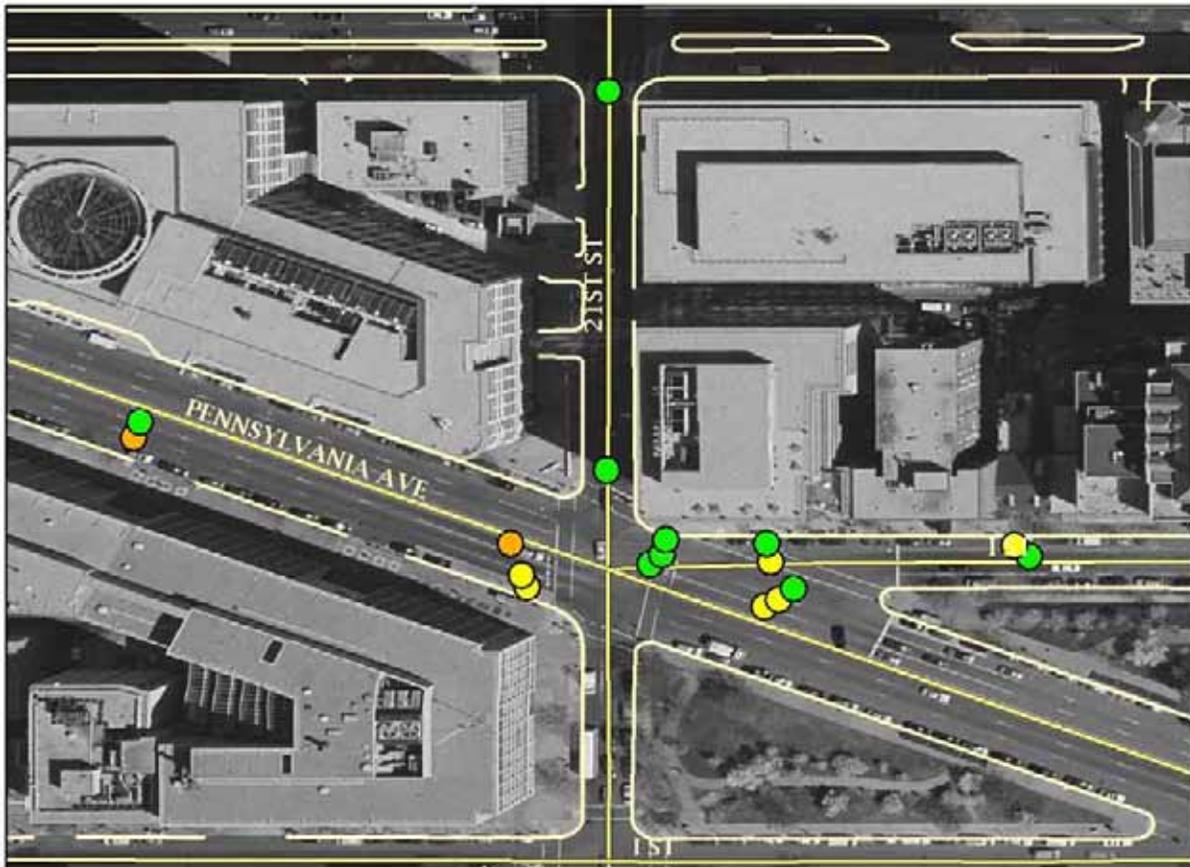
Figure B100 Aerial image of the test location color coded by SN Range.

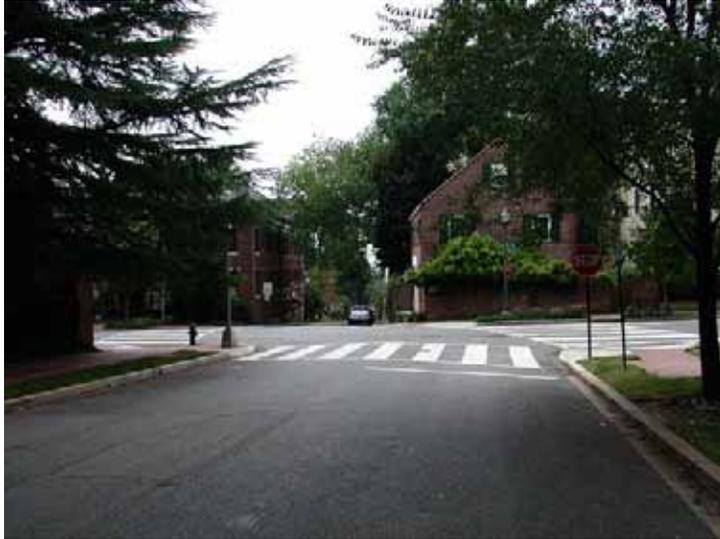
Figure B101. This photo shows the intersection of 32<sup>nd</sup> St & R St as seen from 32<sup>nd</sup> St facing south.

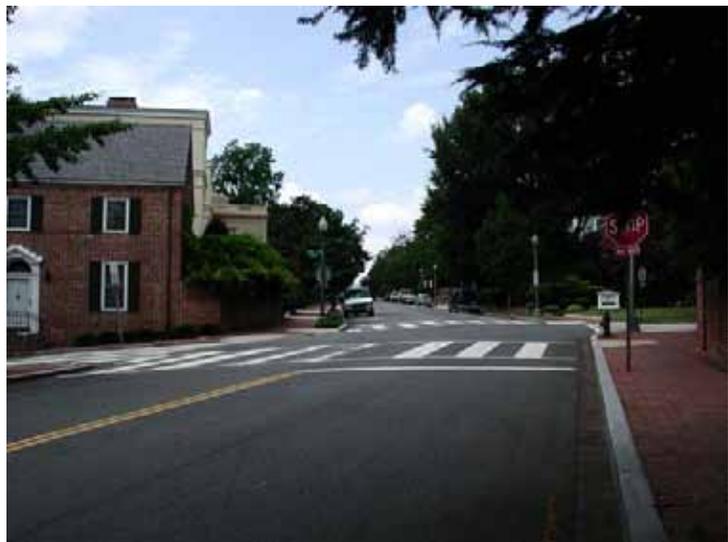
Figure B102. This photo shows the intersection of 32<sup>nd</sup> St & R St as seen from R St facing west.

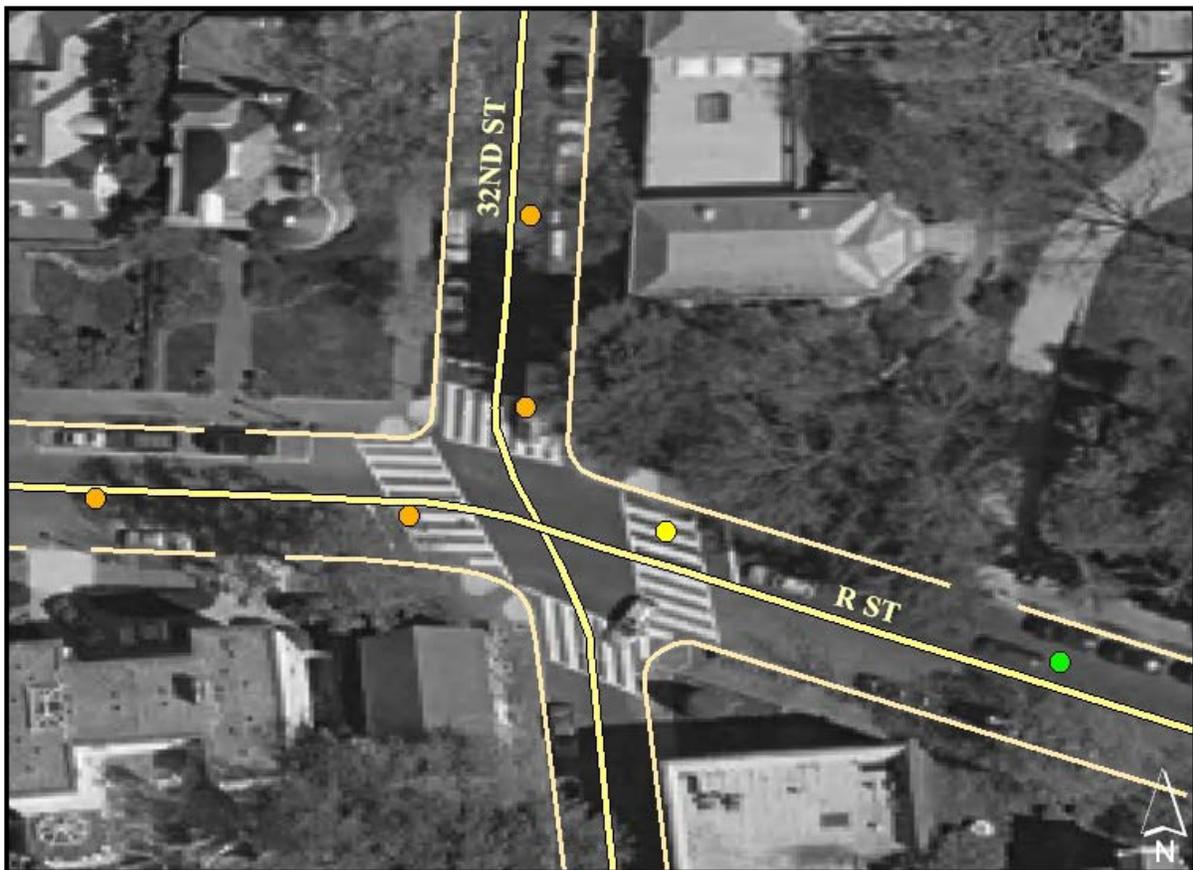
Figure B104 Aerial image of the test location color coded by SN Range.

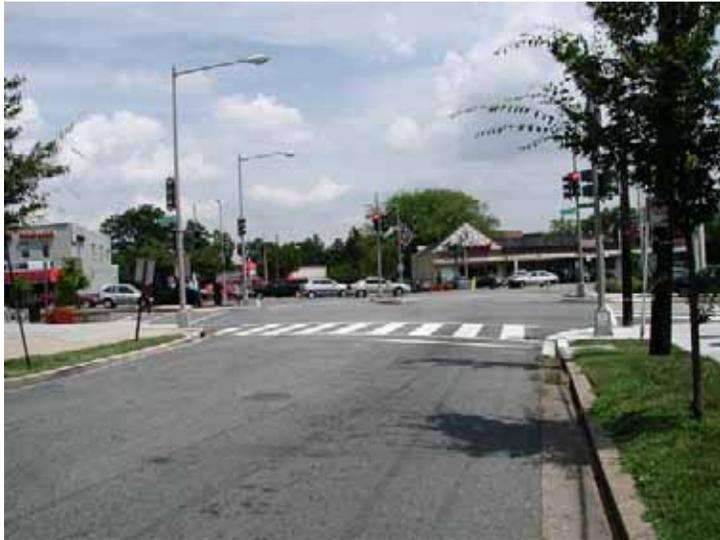
Figure B105. This photo shows the intersection of Georgia Ave & Kalmia Ave as seen from Kalmia Rd facing east.

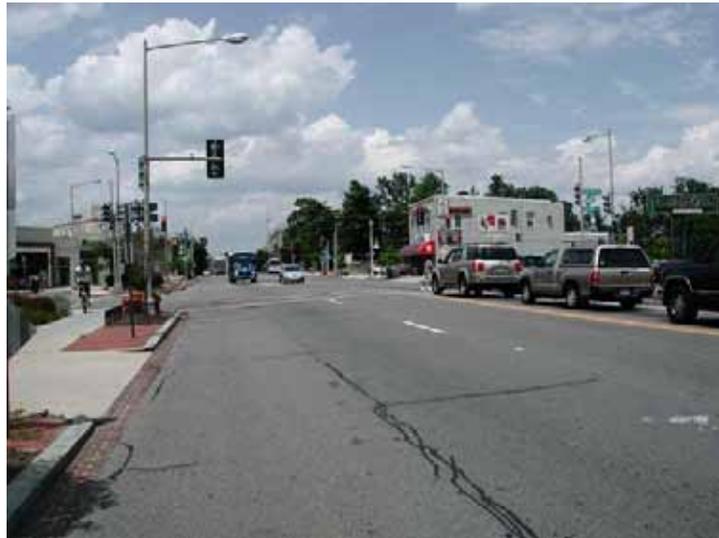
Figure B106. This photo shows the intersection of Georgia Ave & Kalmia Rd as seen from Georgia Ave facing north.

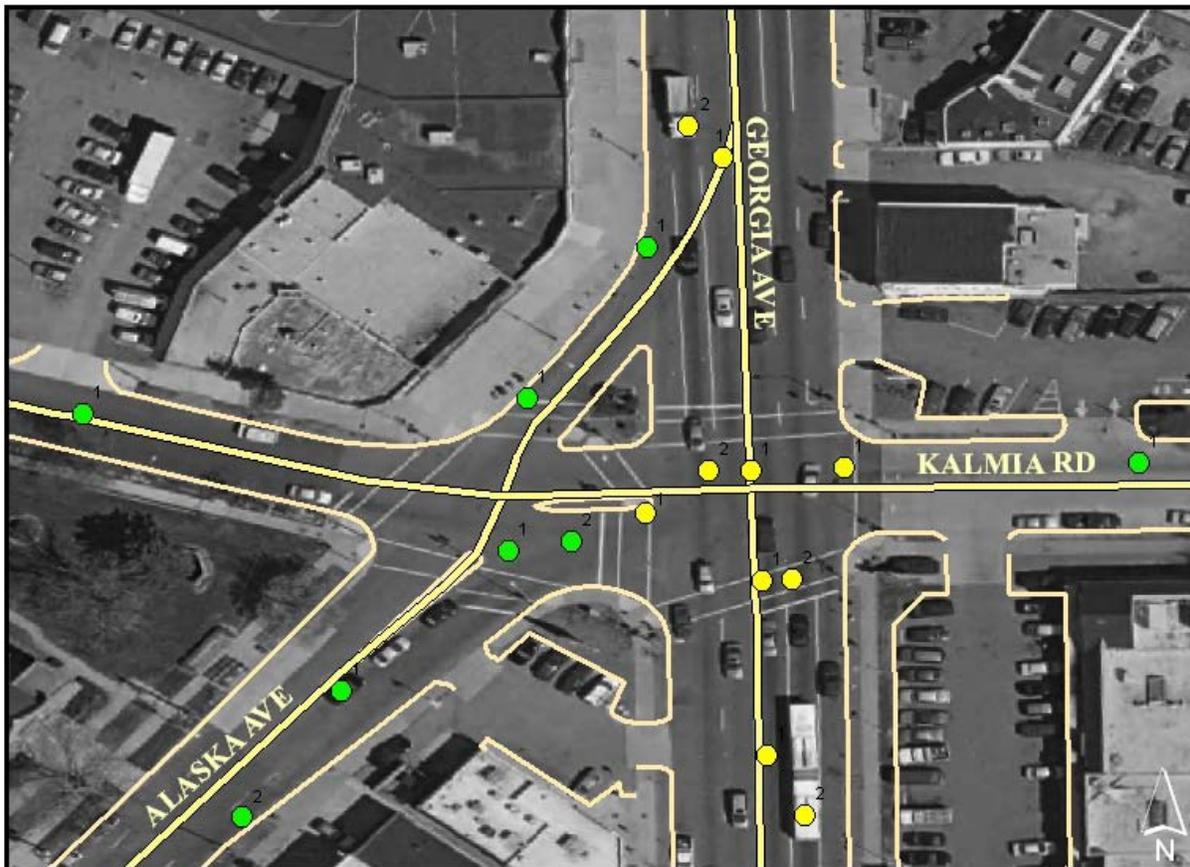
Figure B108 Aerial image of the test location color coded by SN Range.

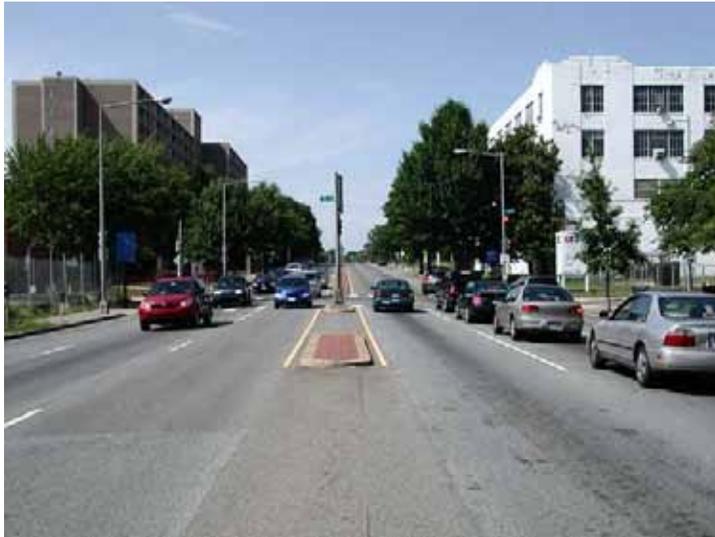
Figure B109. This photo shows the intersection of L St & N Capitol St as seen from N Capitol St facing north.

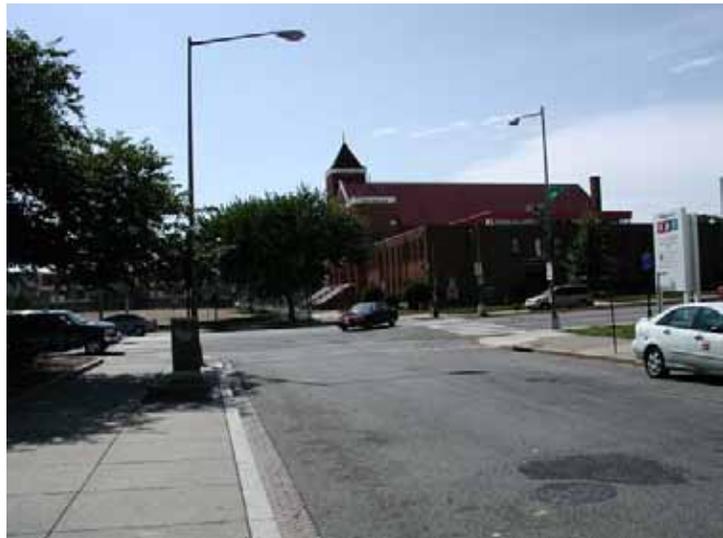
Figure B110. This photo shows the intersection of L St & N Capitol St as seen from L St facing west. L St is an eastbound one way street at this location.
