**Final Report on  
District Wide  
Highway Safety Improvement Program (HSIP)  
Intersection Skid Resistance Testing**

**District Department of Transportation  
Infrastructure Project Management Administration  
Safety, Standards, and Quality Control Division**

**September 11, 2009**

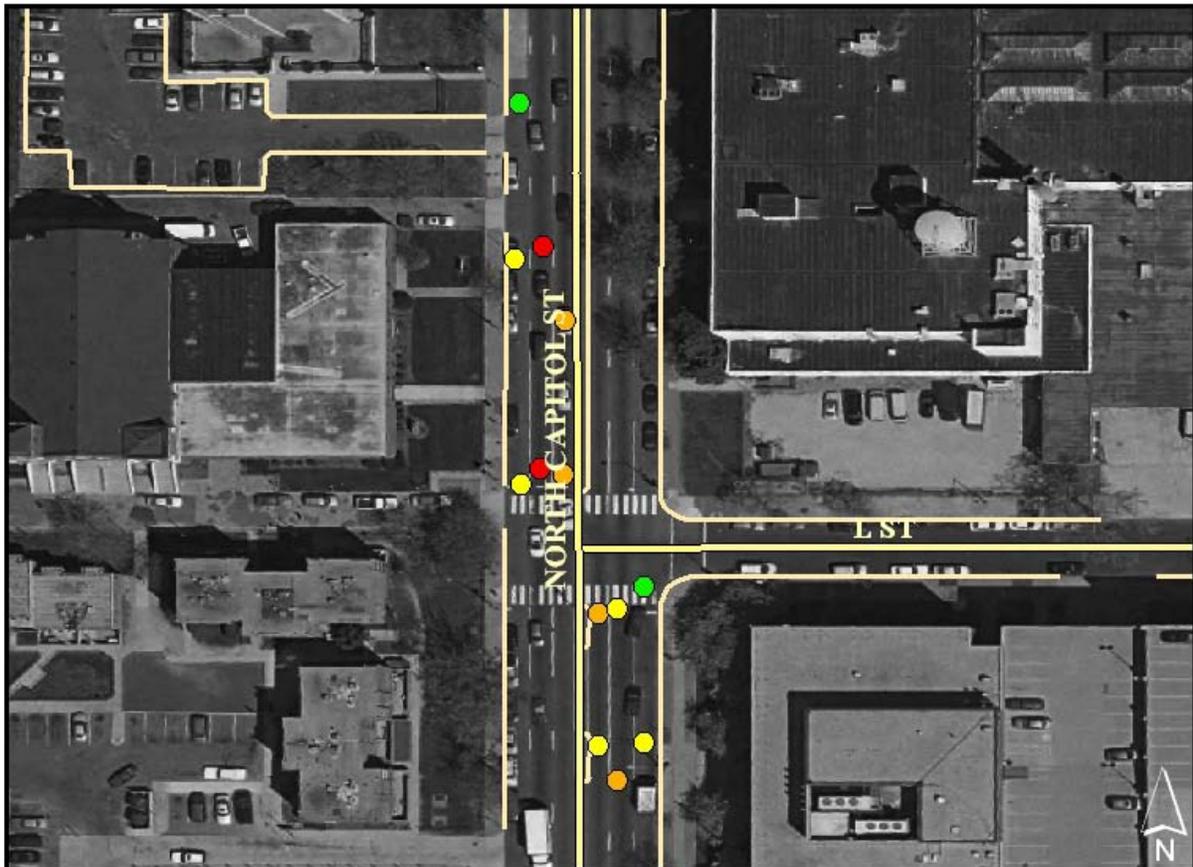
Skid resistance testing was performed on the intersection of L Street and North Capitol Street the night of July 25, 2009. This is a T intersection. No skid resistance tests were completed on L Street because it is a one way road exiting the intersection. Figures B109 & B110 are photographs that show the intersection from two angles. Table B28 shows the number of test results that occurred in each of the designated SN ranges. Figure B111 shows the percentage distribution of test results by SN range at this location. Two tests (15.4%) resulted in an SN<26 and 53.8% of the tests had an SN>=33. Both tests that scored below 26 are all located on southbound, lane 2 on North Capitol Street. Figure B112 is an aerial image of the intersection showing a color coded dot which represents the start point of each skid test.

Figure B112 Aerial image of the test location color coded by SN Range.

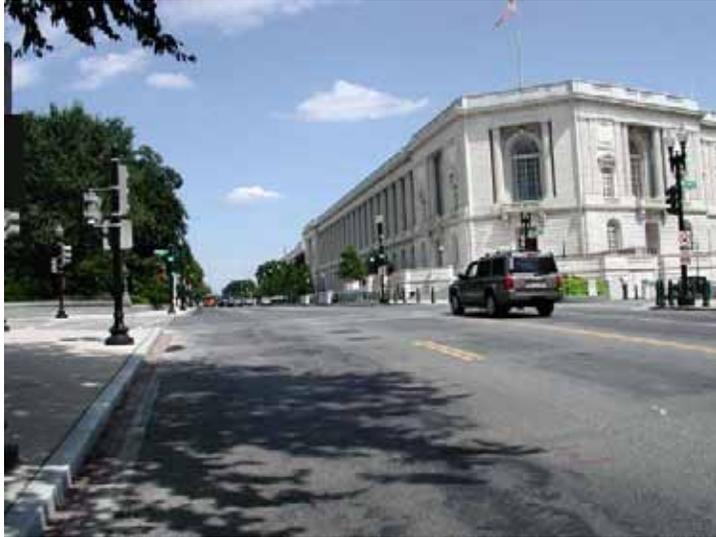
Figure B113. This photo shows the intersection of Independence Ave & S Capitol St as seen from Independence Ave facing east.

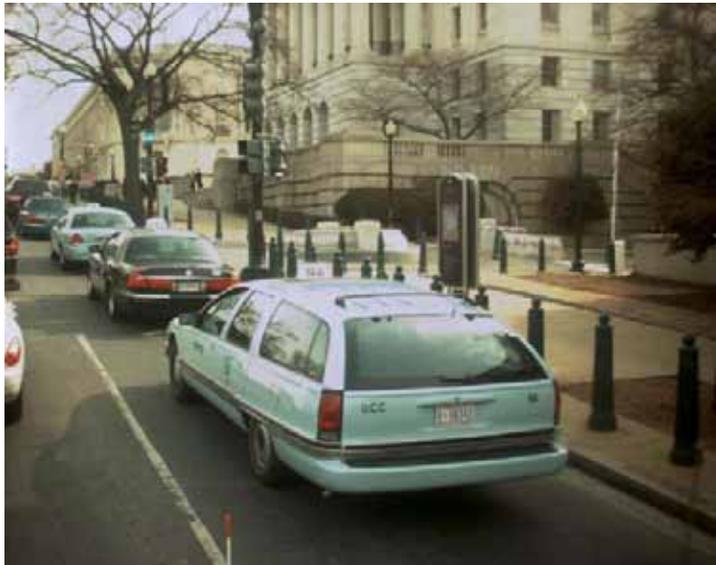
Figure B114. This photo shows the intersection of Independence Ave & S Capitol St as seen from Independence Ave. S Capitol St between Independence Ave and C St has been closed to public access for security reasons since 2002.

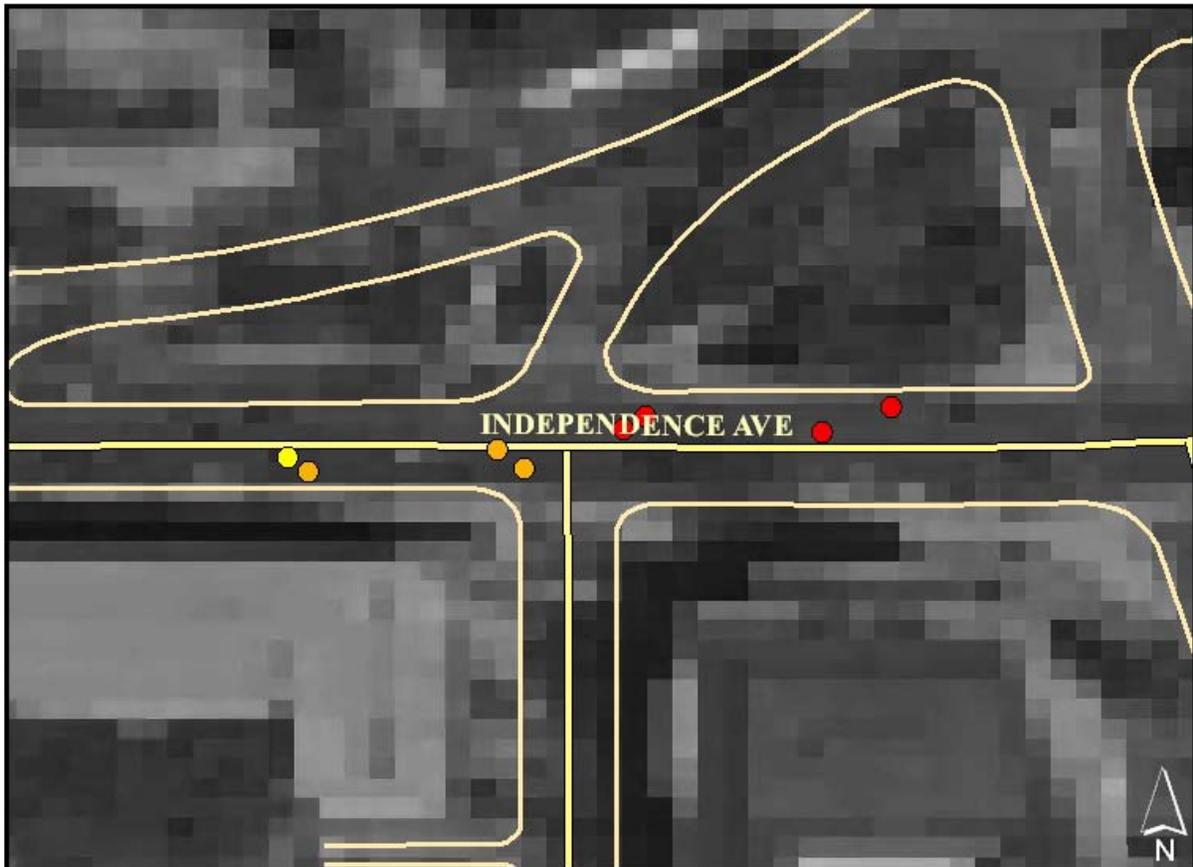
Skid resistance testing was performed on the intersection of Independence Avenue and South Capitol Street the night of July 26, 2009. S Capitol Street is closed due to security concerns. All testing was performed on Independence Ave. Figures B113 & B114 are photographs that show the intersection from two angles. Table B29 shows the number of test results that occurred in each of the designated SN ranges. Figure B115 shows the percentage distribution of test results by SN range at this location. Four tests (50.0%) resulted in an SN<26 and 12.5% of the tests had an SN>=33. The four tests that scored below 26 are all located on westbound Independence

Avenue. Figure B116 is an aerial image of the intersection showing a color coded dot which represents the start point of each skid test.

Figure B116 Aerial image of the test location color coded by SN Range.

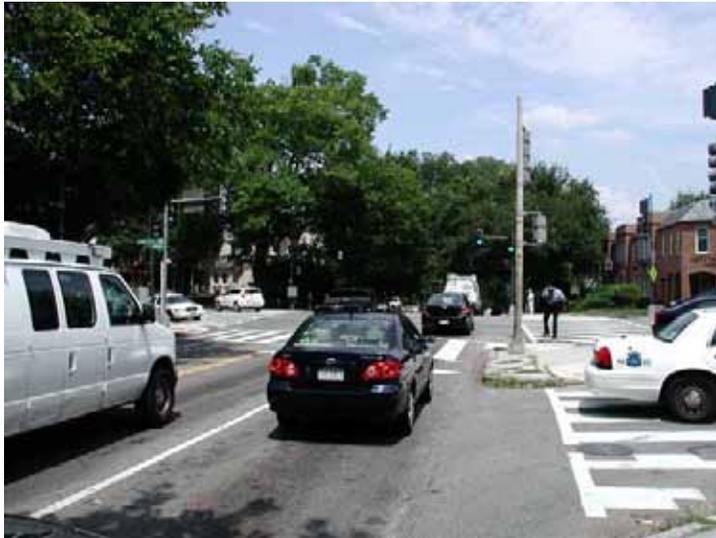
Figure B117. This photo shows the intersection of Nebraska Ave & Connecticut Ave as seen from Nebraska Ave facing northeast.

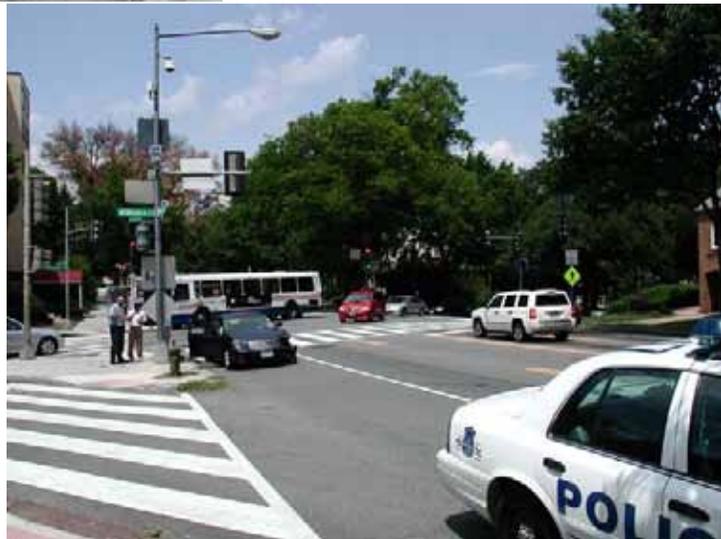
Figure B118. This photo shows the intersection of Nebraska Ave & Connecticut Ave as seen from Connecticut Ave facing north.

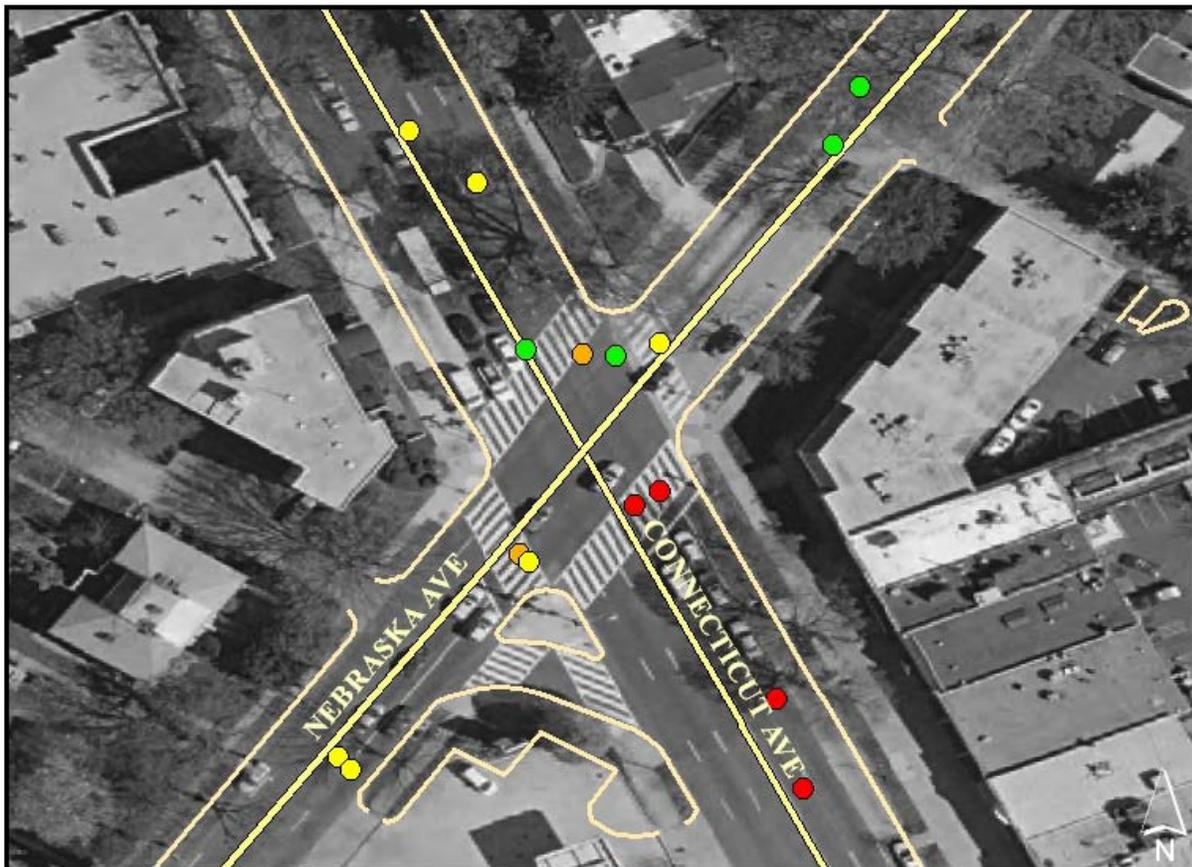
Skid resistance testing was performed on the intersection of Connecticut Avenue and Nebraska Avenue the night of July 25, 2009. This is a major intersection of two multi-lane roadways. Figures B117 & B118 are photographs that show the intersection from two angles. Table B30 shows the number of test results that occurred in each of the designated SN ranges. Figure B119 shows the percentage distribution of test results by SN range at this location. Four tests (25%) resulted in a SN<26 and 62.5% of the tests had an SN>=33. The four tests that scored below 26 are all located on northbound Connecticut Avenue. Figure B120 is an aerial image of the intersection showing a color coded dot which represents the start point of each skid test.

Figure B120 Aerial image of the test location color coded by SN Range.
